# Accident Investigation Overview

## Crandall Canyon Mine Disaster

U.S. Dept. of Labor, Mine Safety and Health Administration  
Utah Commission of Labor

Utah Mine Safety Commission Briefing

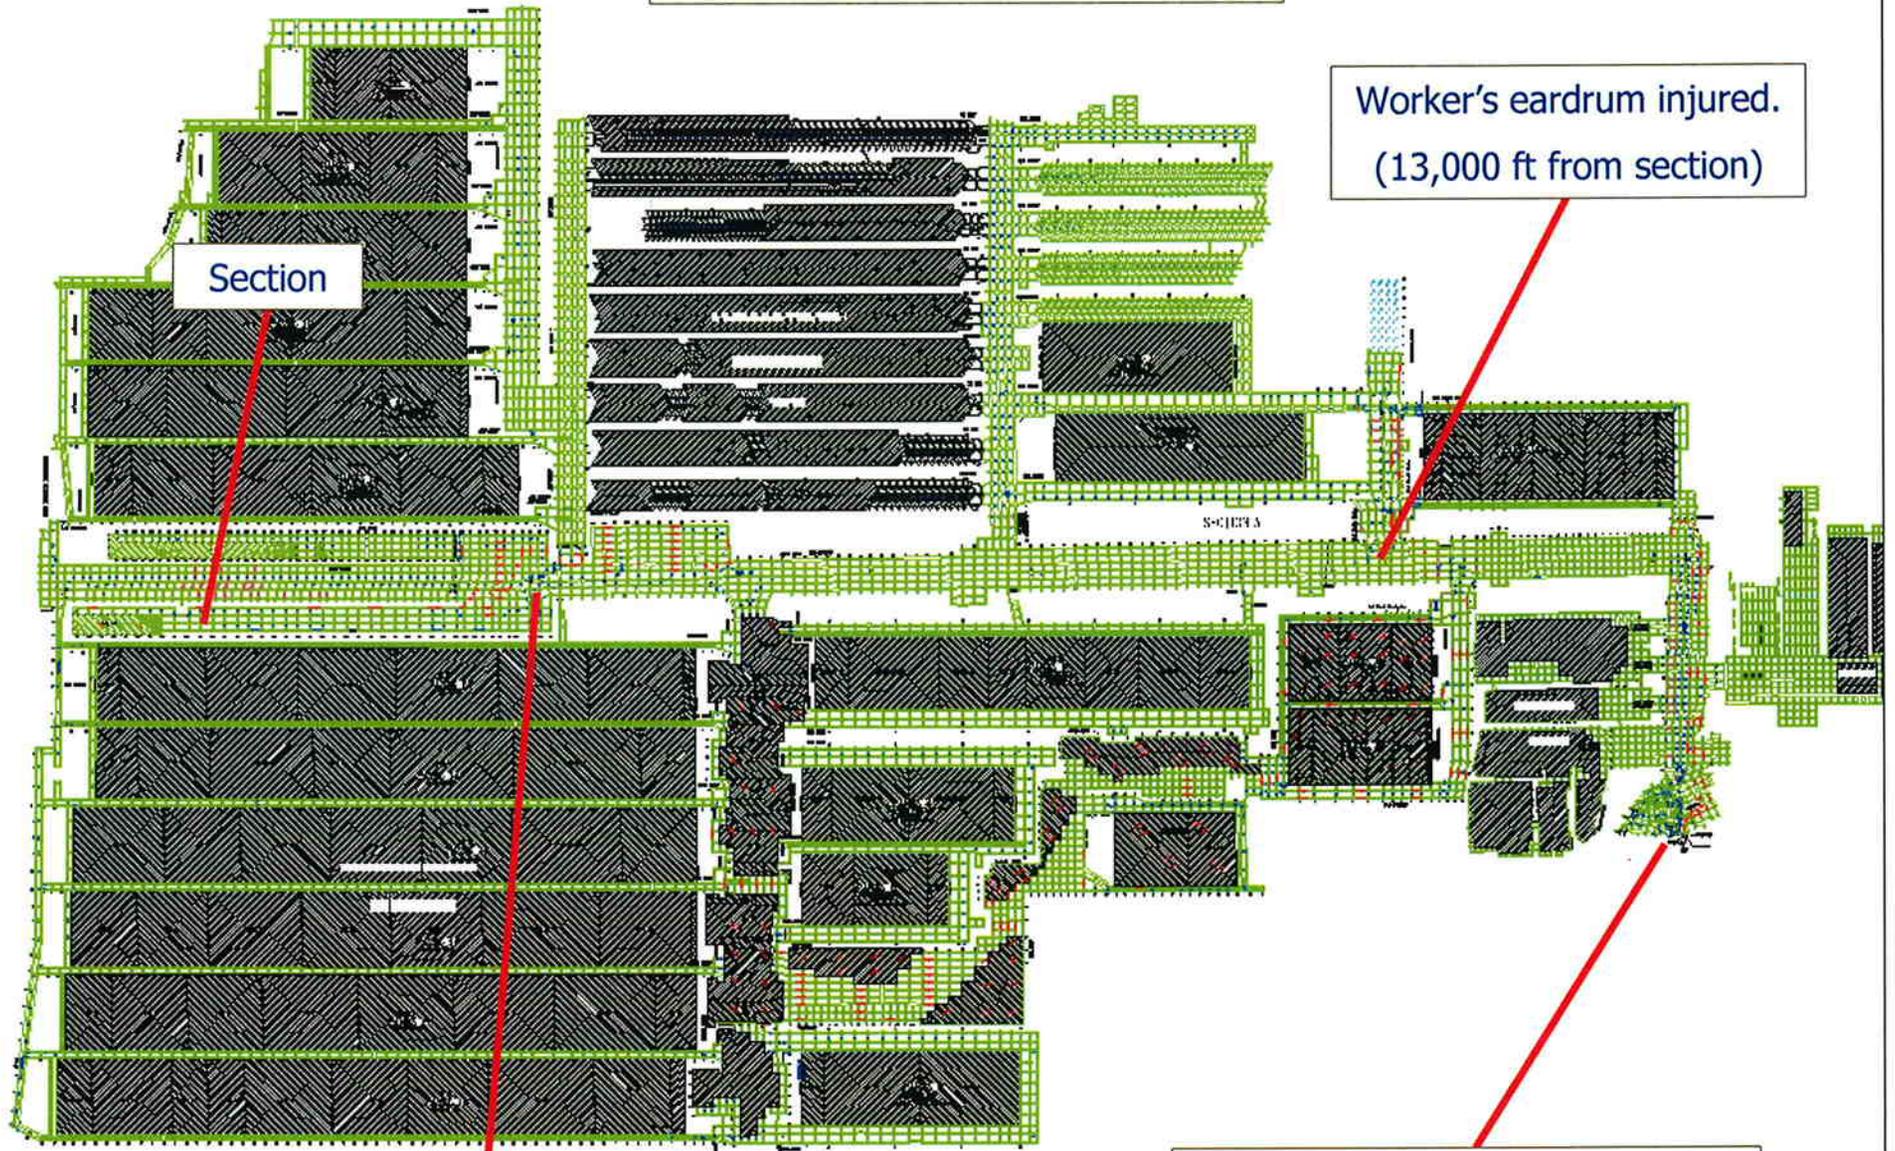
Worker's eardrum injured.  
(13,000 ft from section)

Mechanic had truck blown sideways.  
(4,000 ft from section)

Office building shook on surface.  
(~3 miles from section)

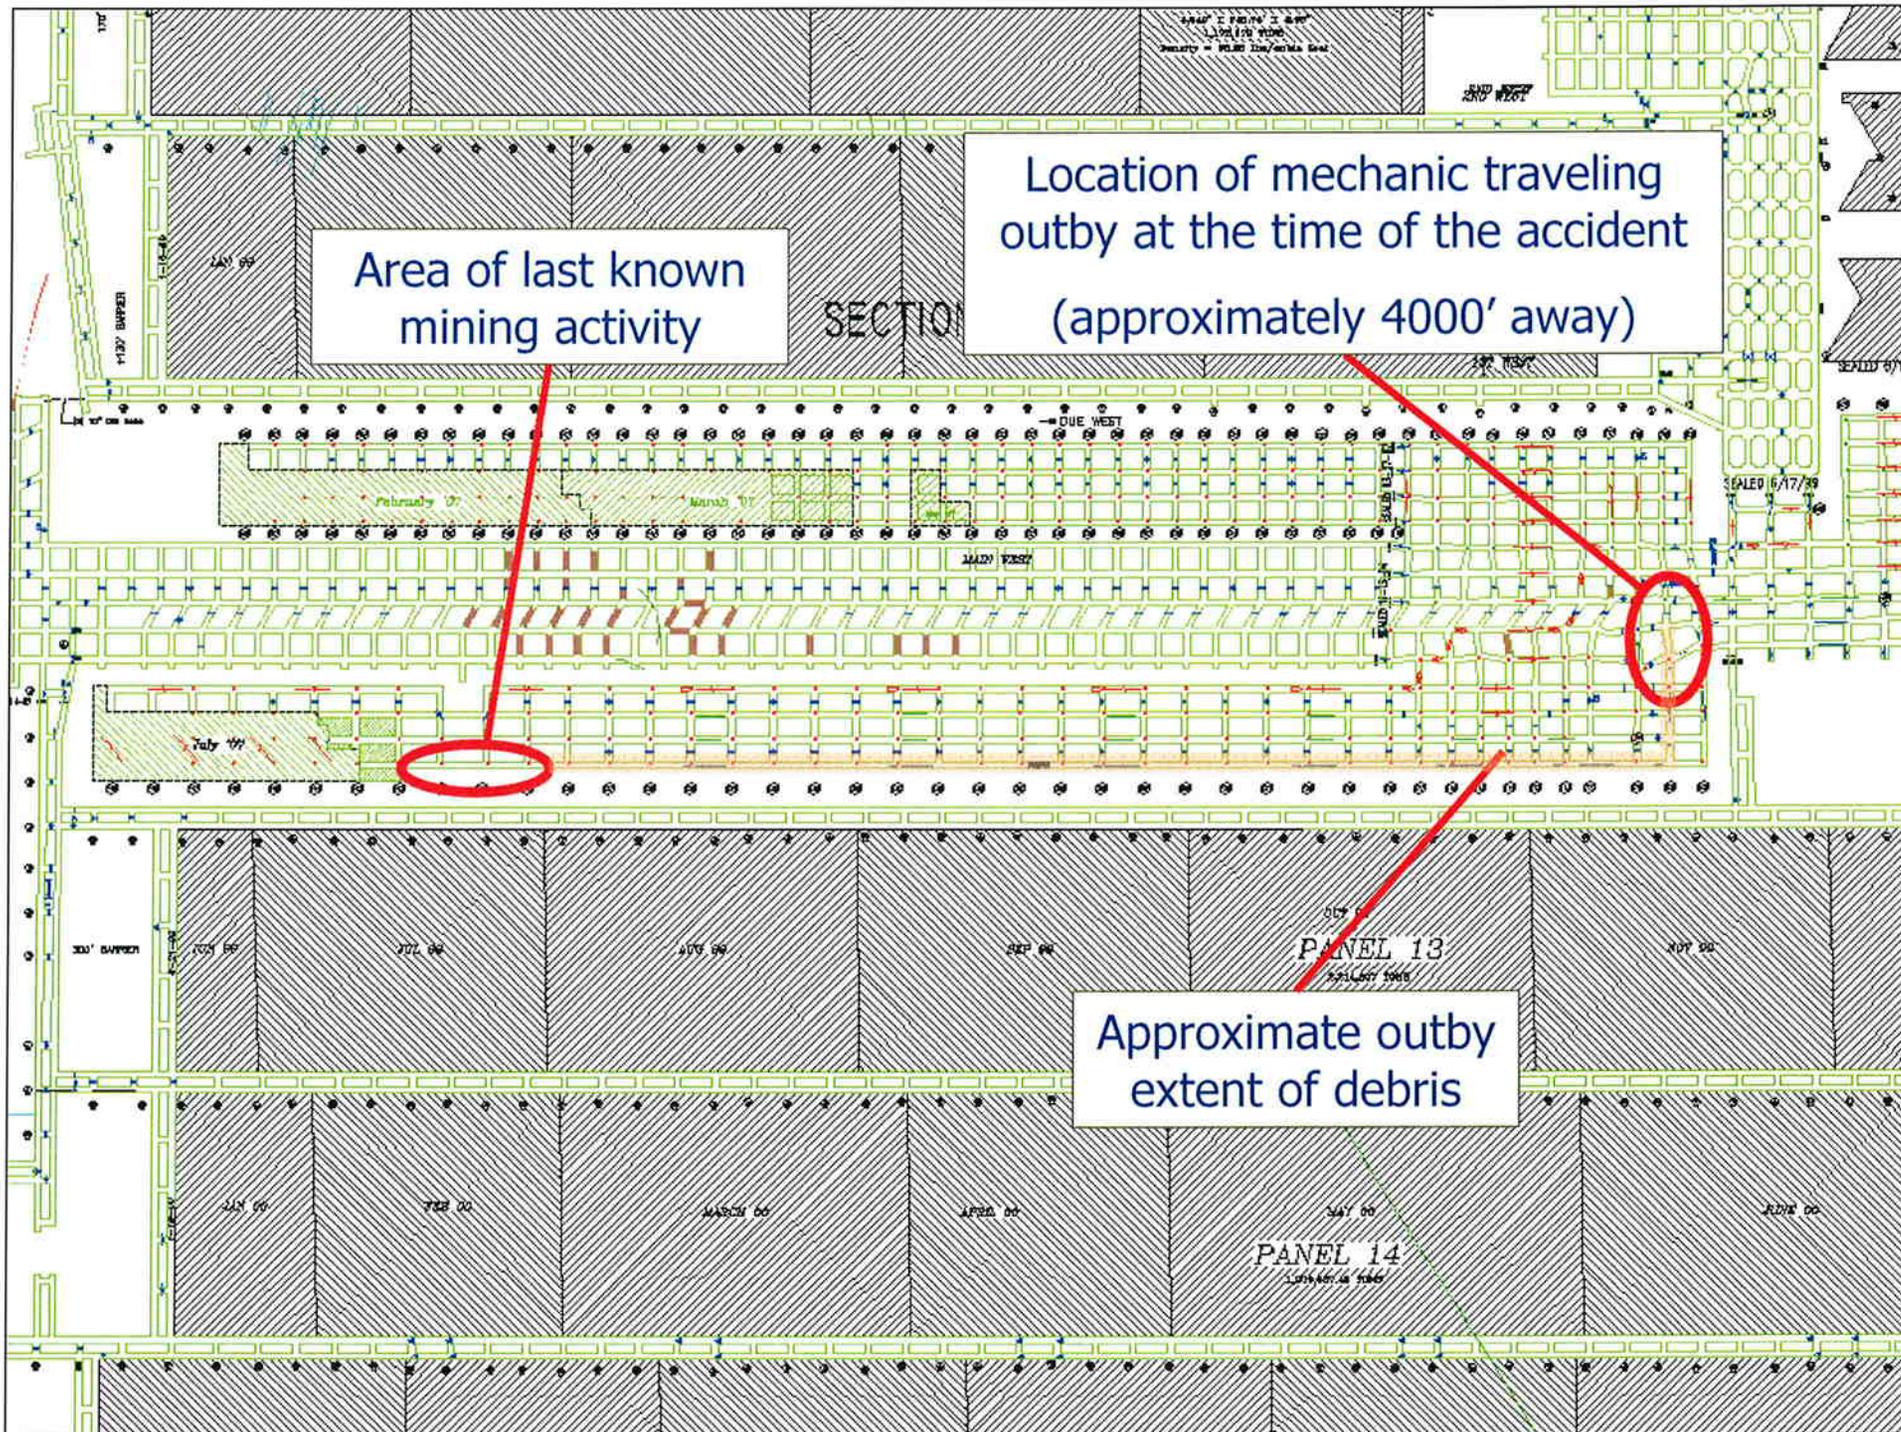
Area of last known mining activity

Location of mechanic traveling outby at the time of the accident (approximately 4000' away)

Approximate outby extent of debris

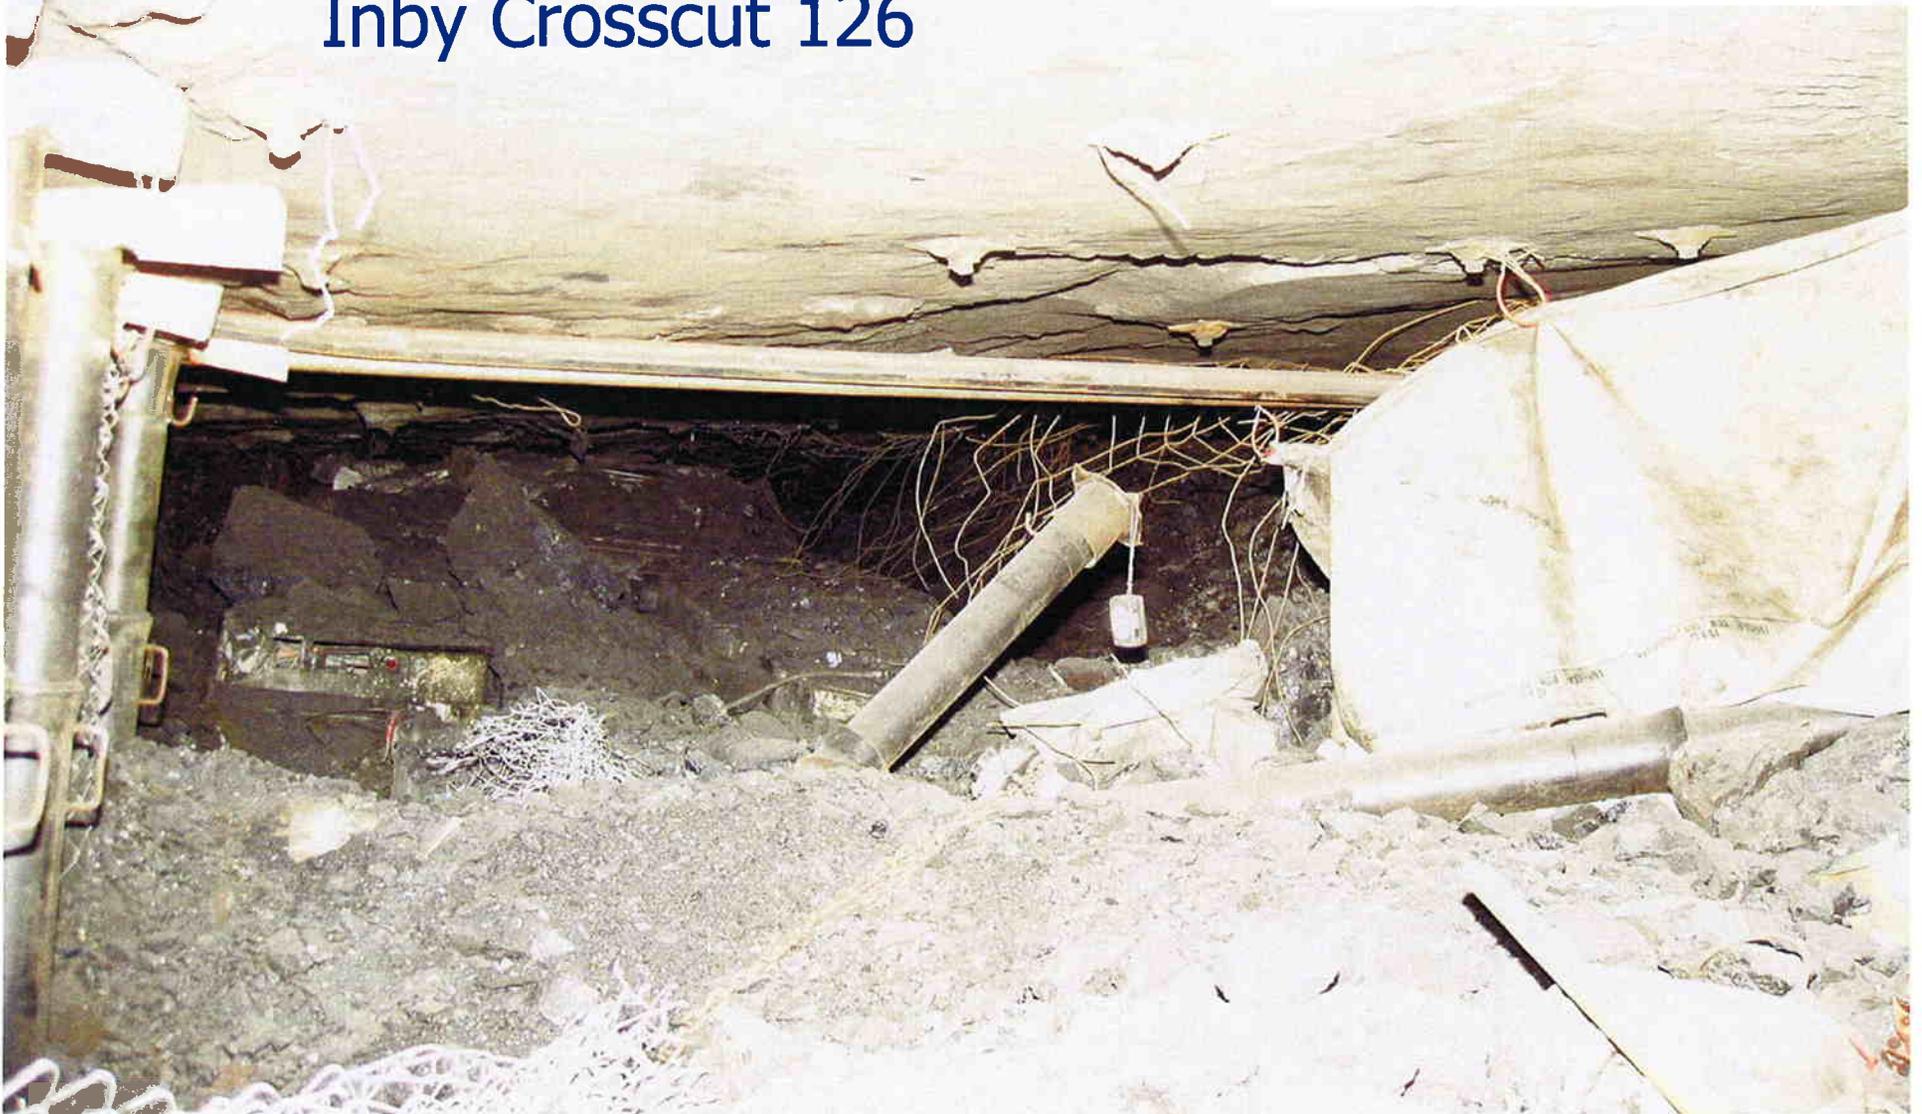
Site of August 16<sup>th</sup> Accident  
9/10/07 – #1 Entry  
Inby Crosscut 126

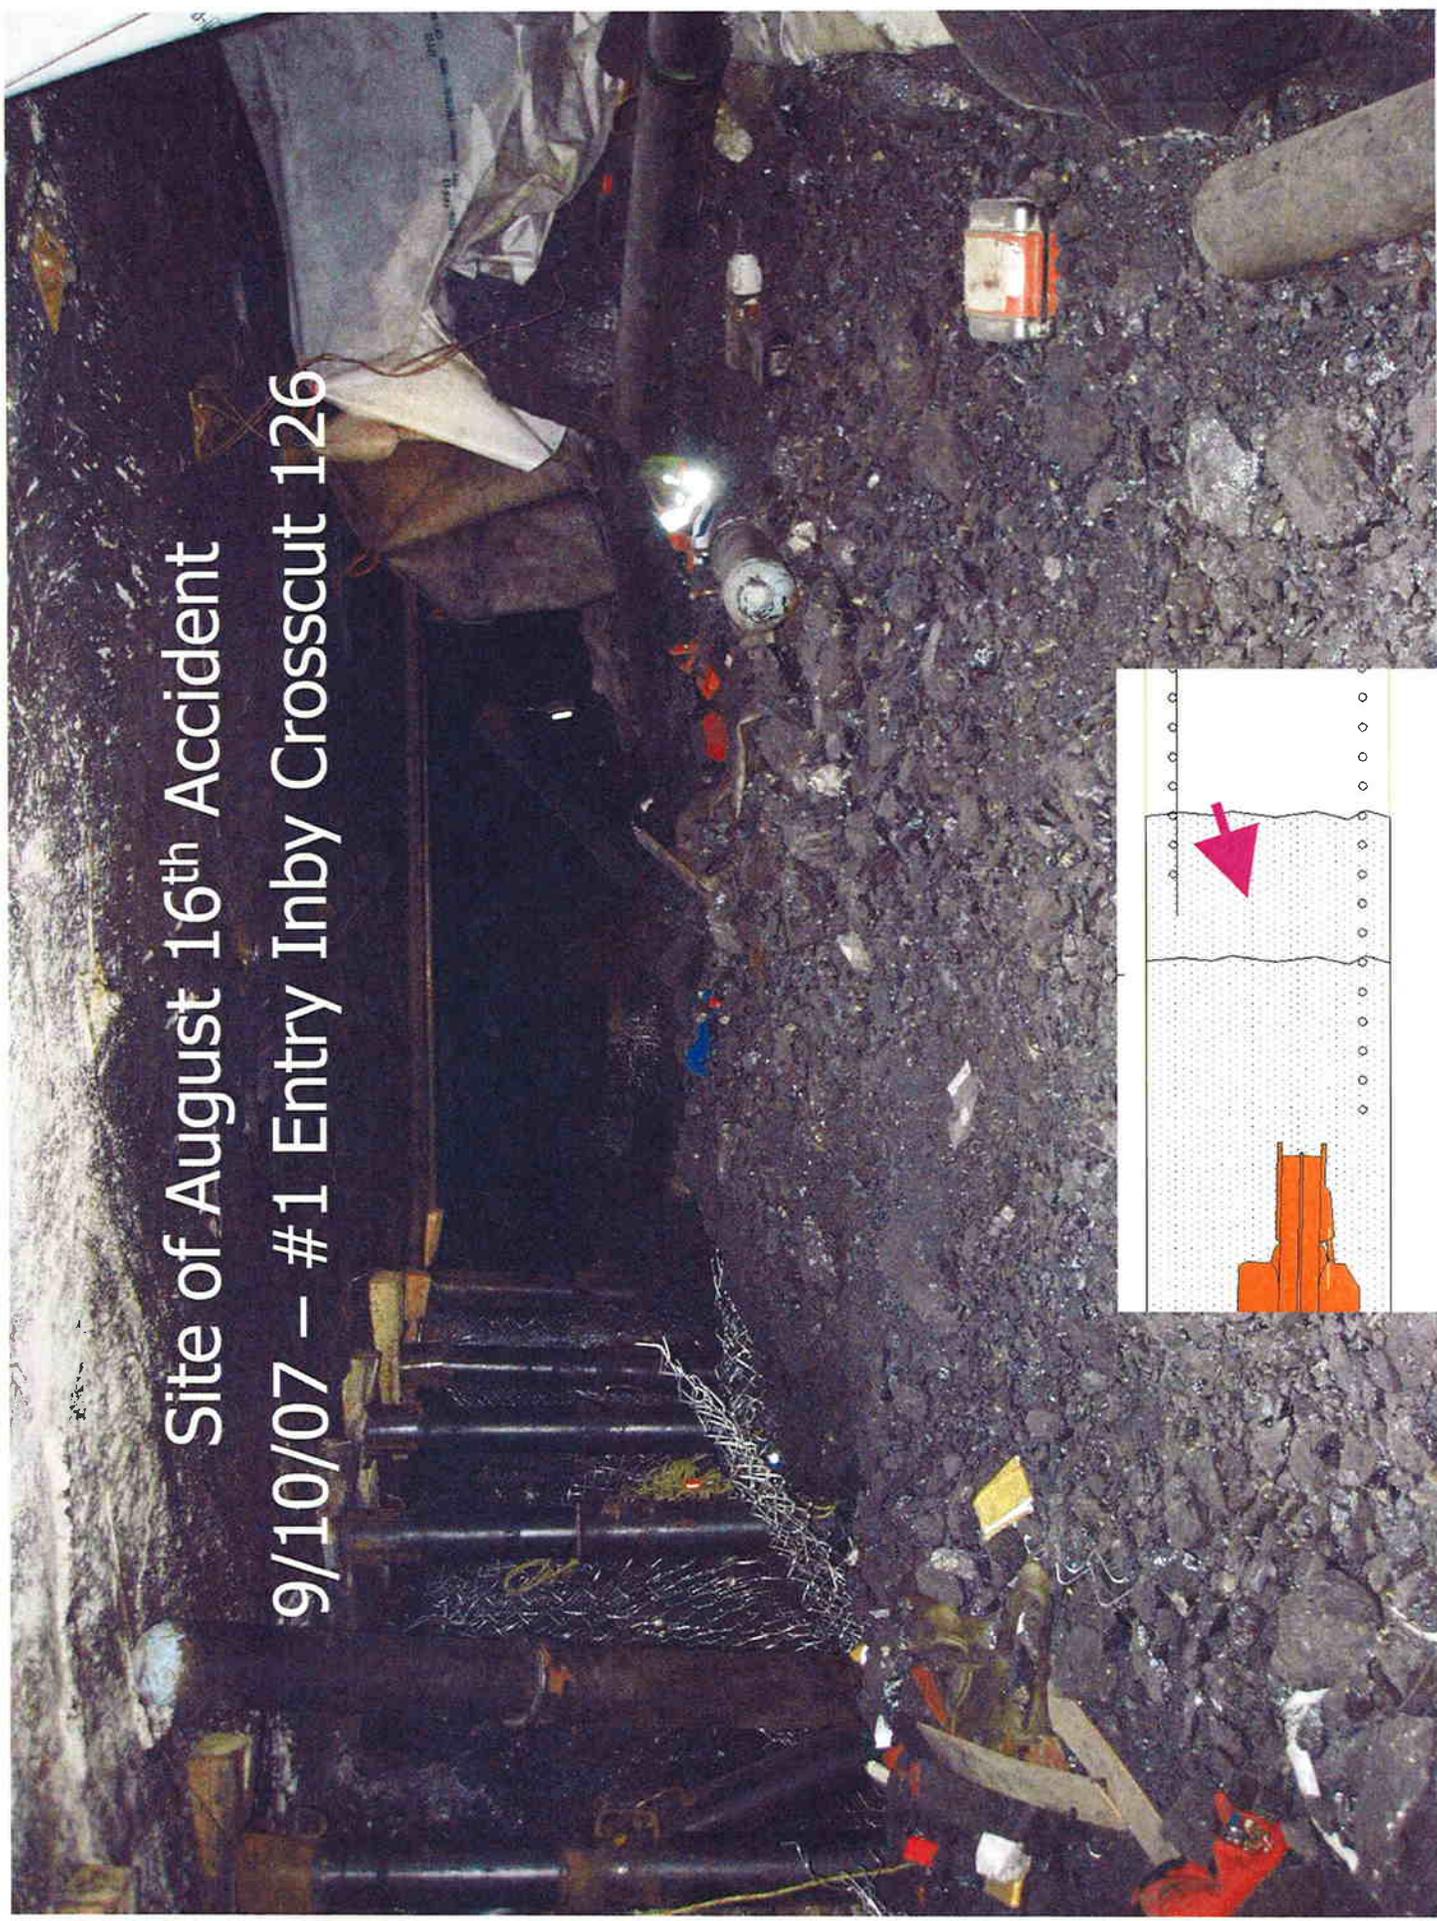
Site of August 16<sup>th</sup> Accident  
9/10/07 – #1 Entry Inby Crosscut 126

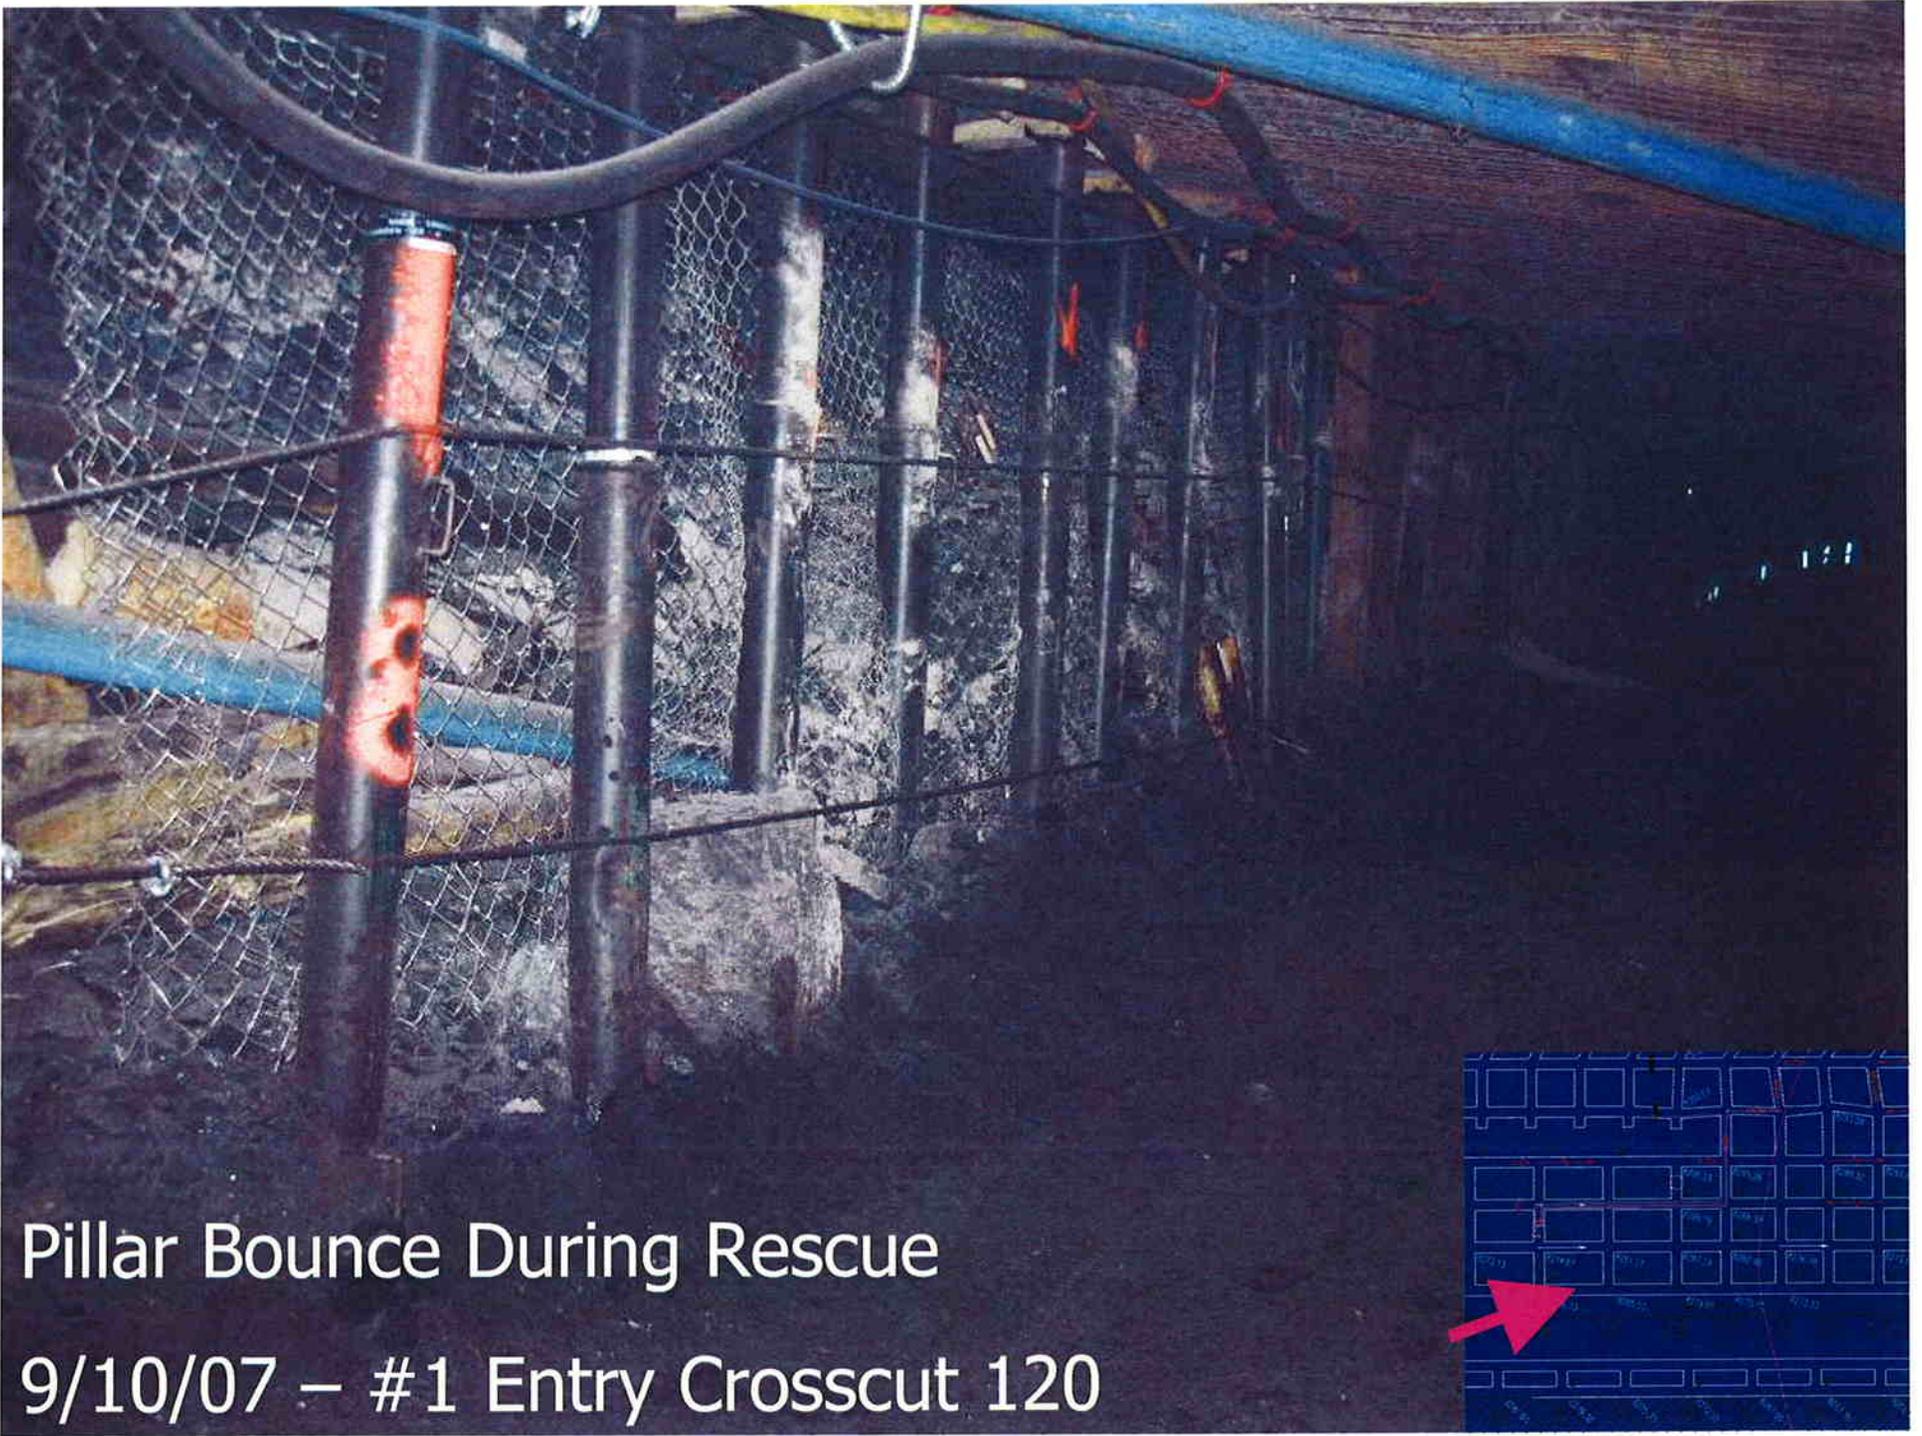
9/10/07 – #1 Entry Crosscut 120

Pillar Bounce During Rescue

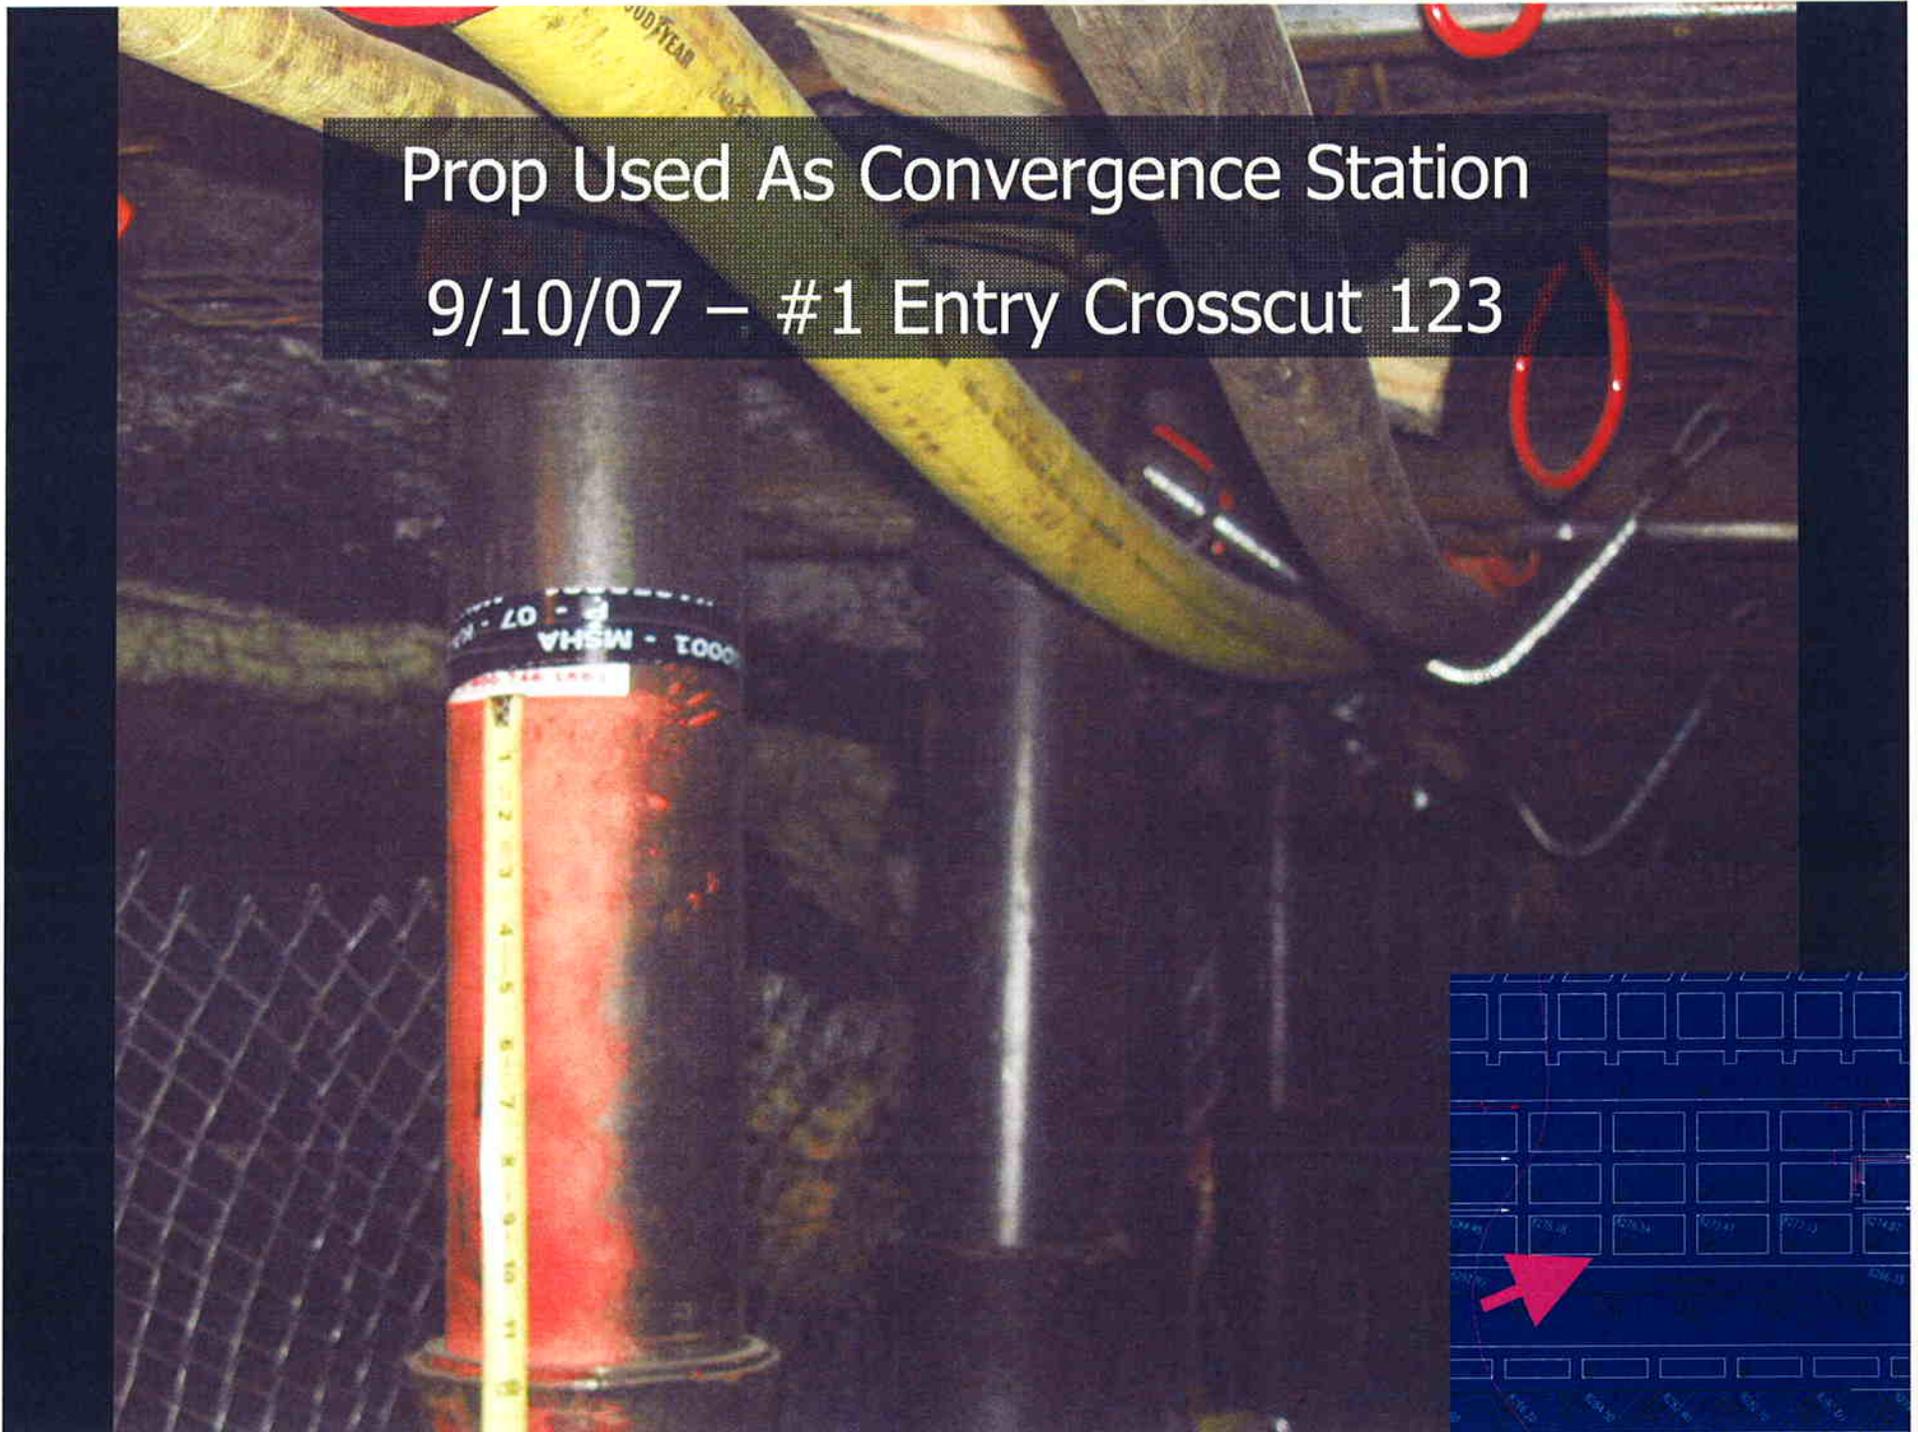
9/10/07 – #1 Entry Crosscut 123

# Prop Used As Convergence Station

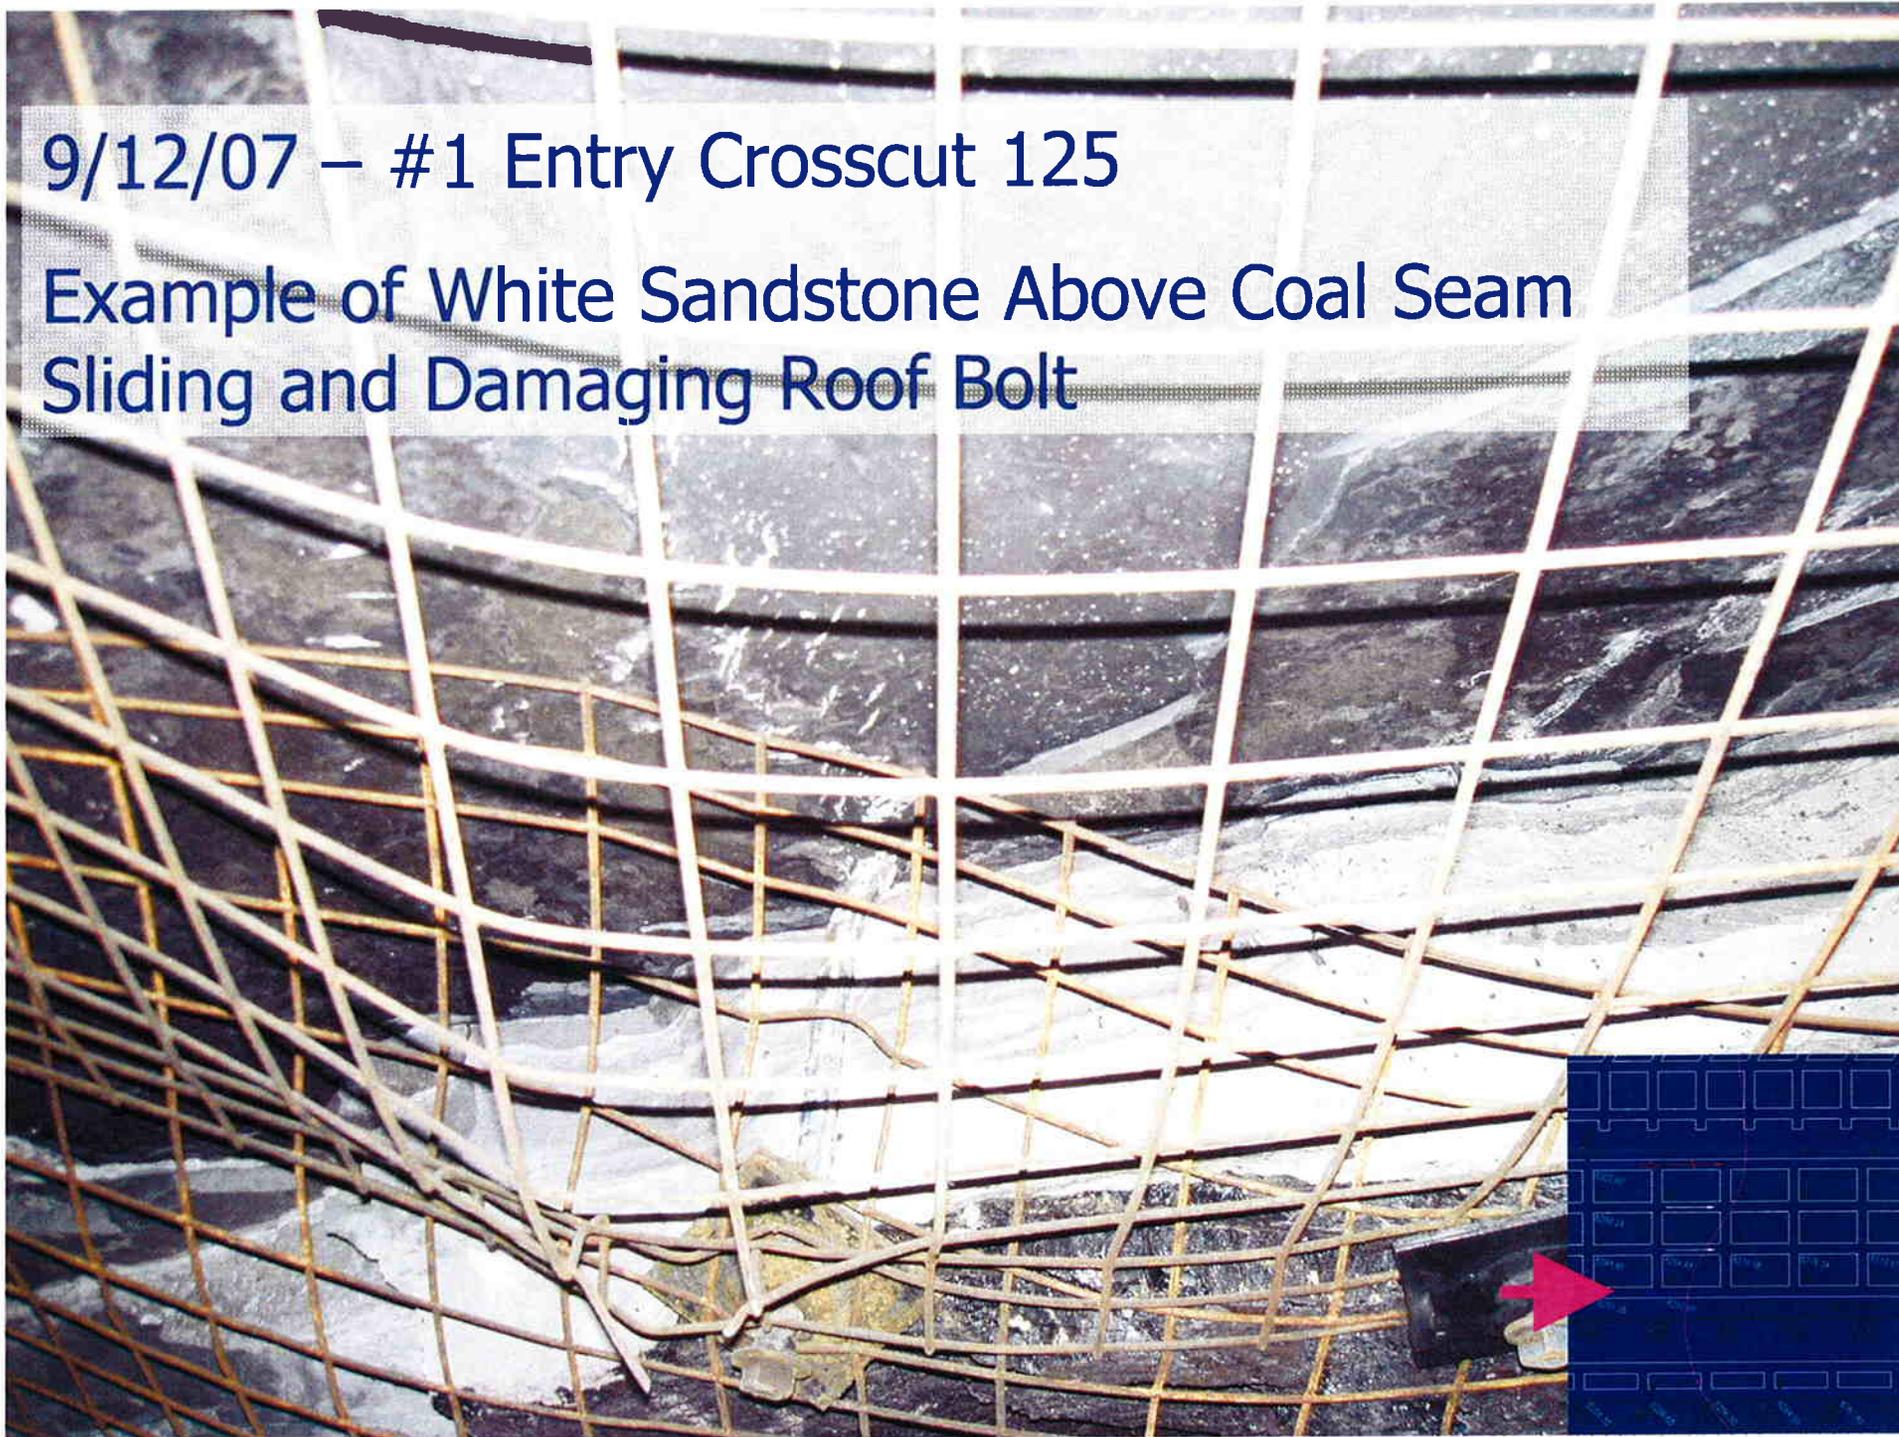
9/12/07 – #1 Entry Crosscut 125

Example of White Sandstone Above Coal Seam  
Sliding and Damaging Roof Bolt

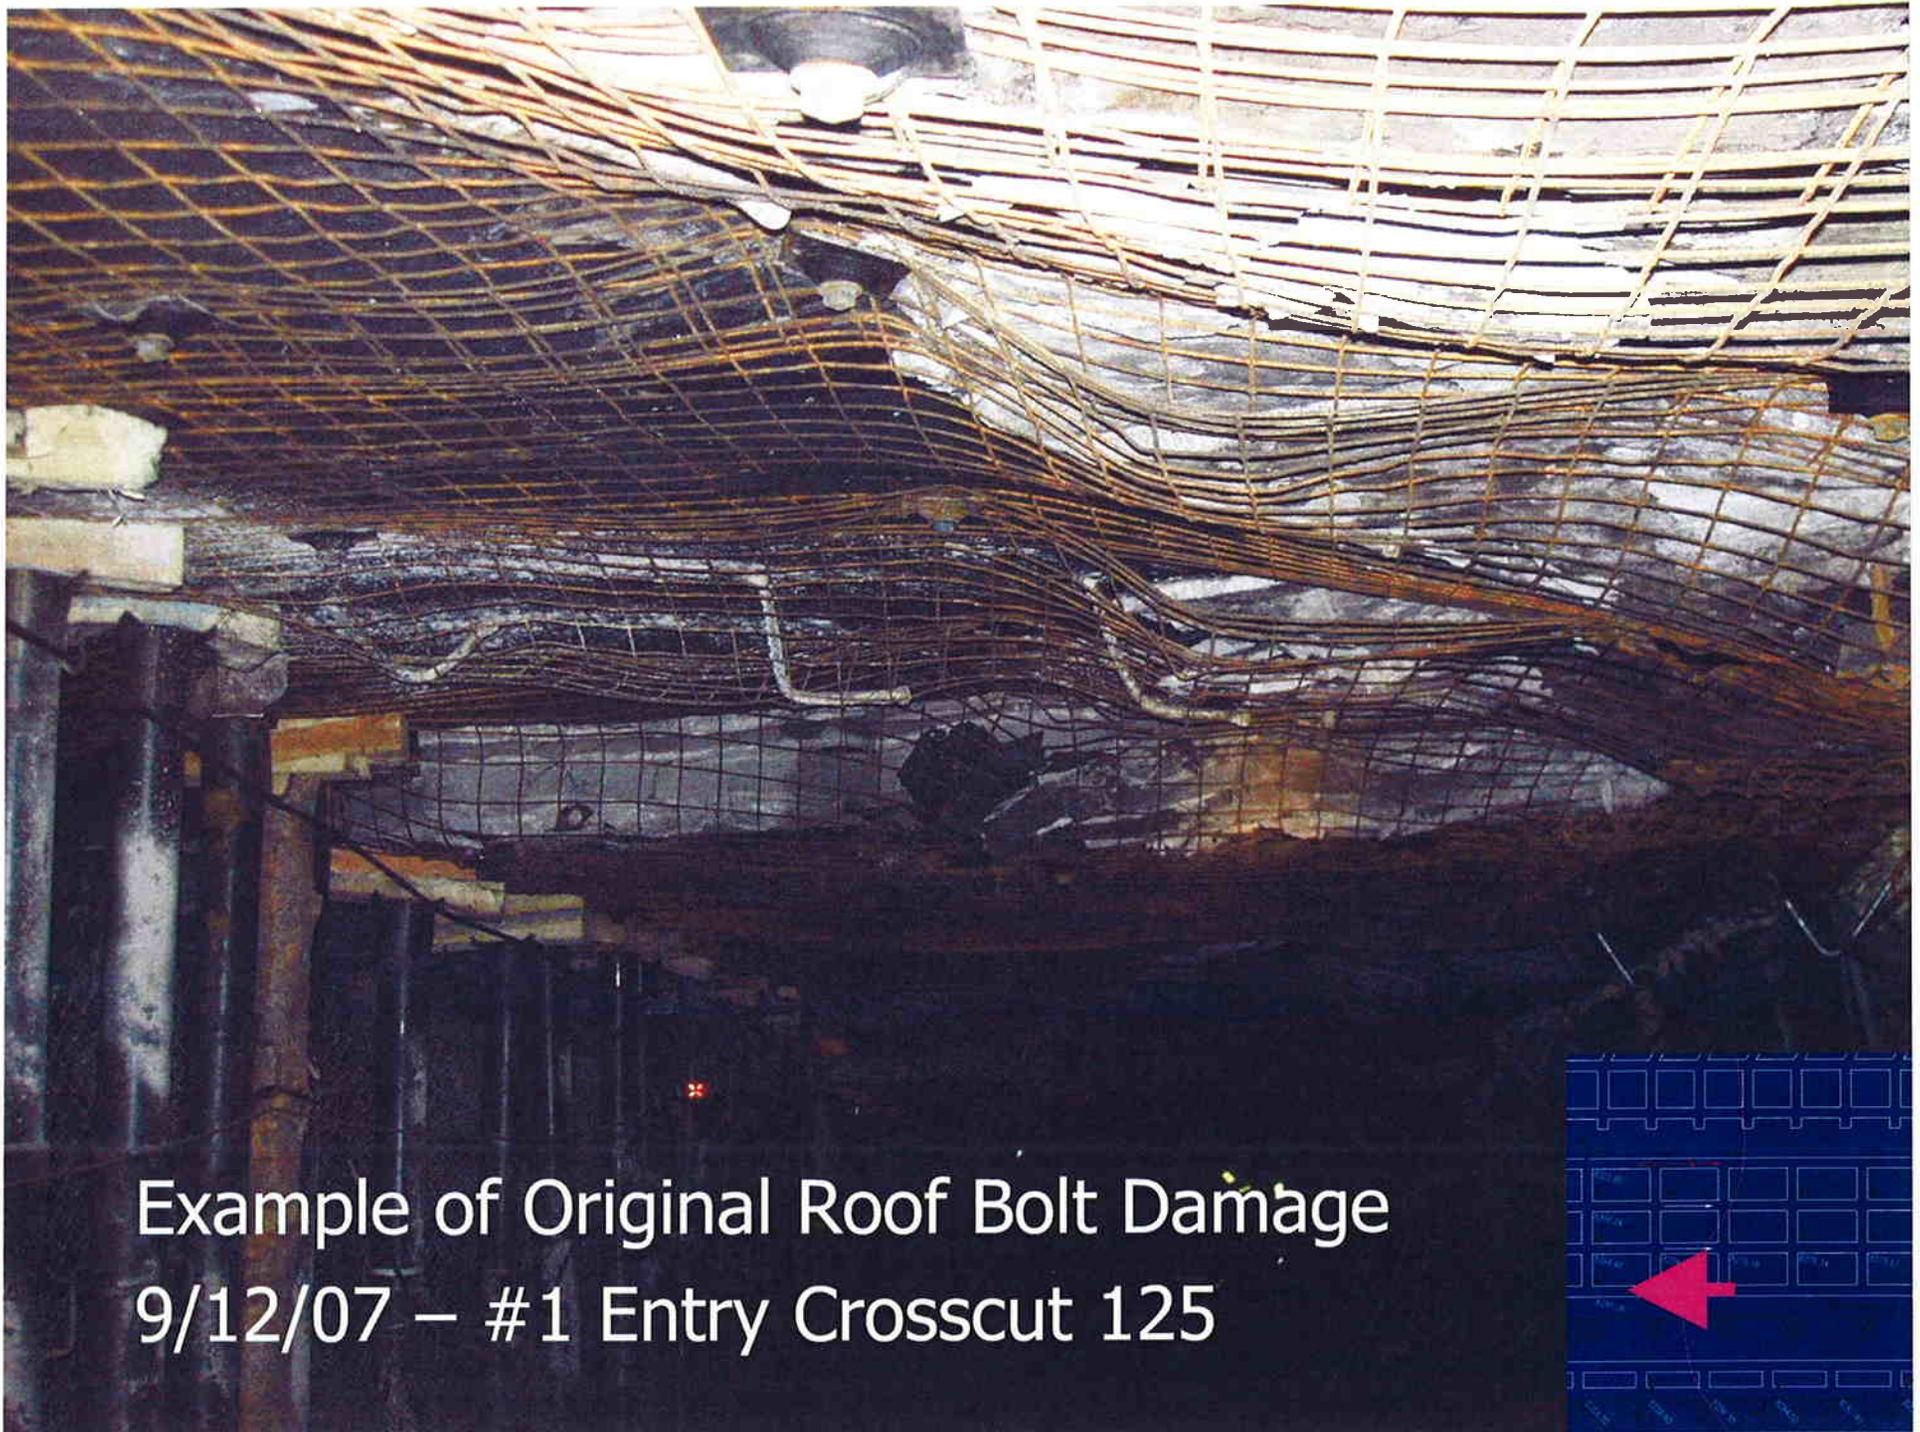
Example of Original Roof Bolt Damage  
9/12/07 – #1 Entry Crosscut 125
