# Accident Investigation Overview

## Crandall Canyon Mine Disaster

U.S. Dept. of Labor, Mine Safety and Health Administration  
Utah Commission of Labor

Utah Mine Safety Commission Briefing

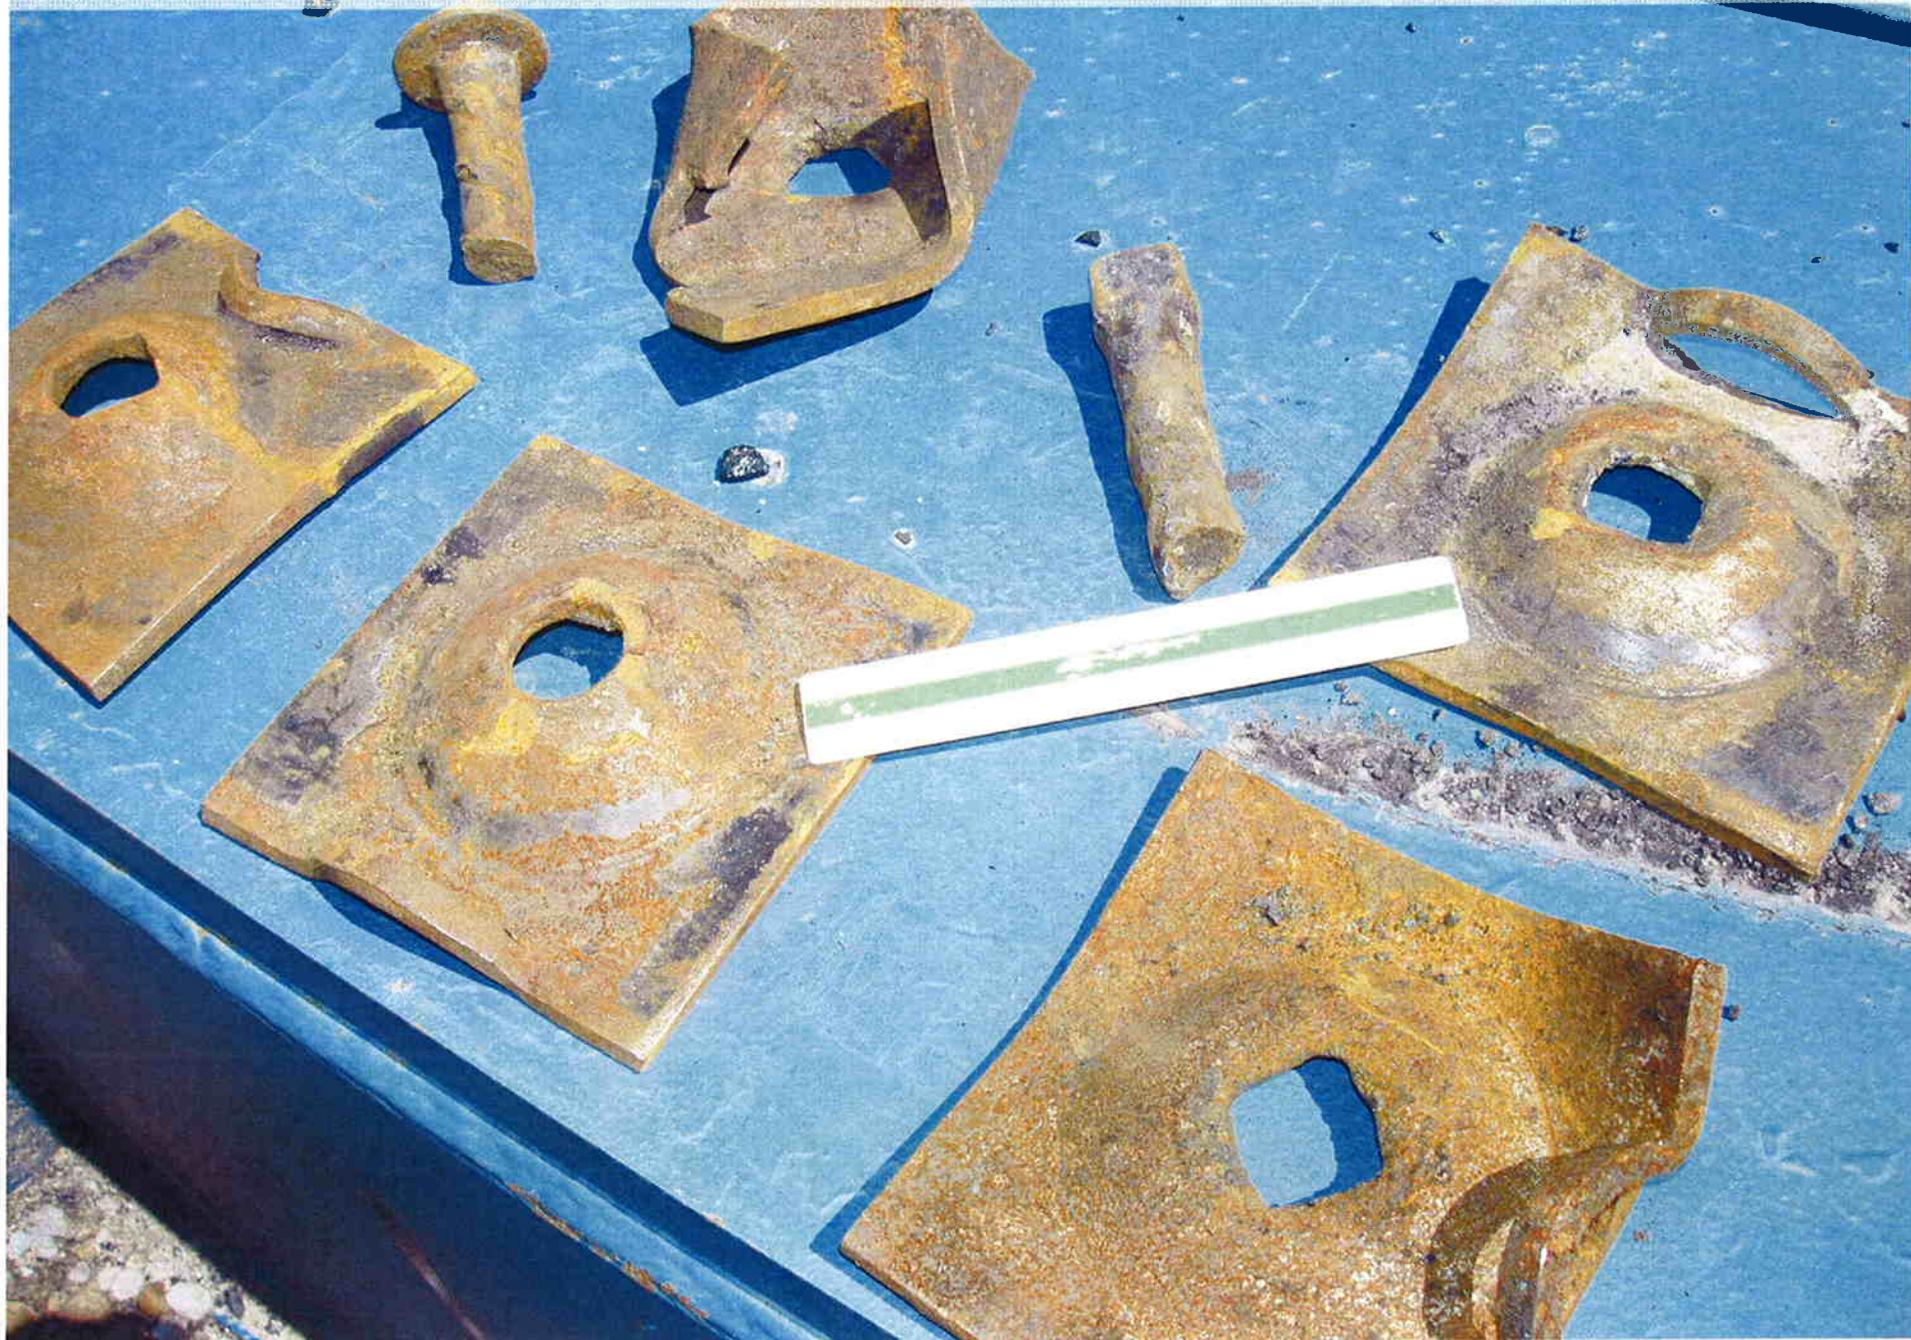
Damaged plates/bolts from outside belt magnet - 9/12/07

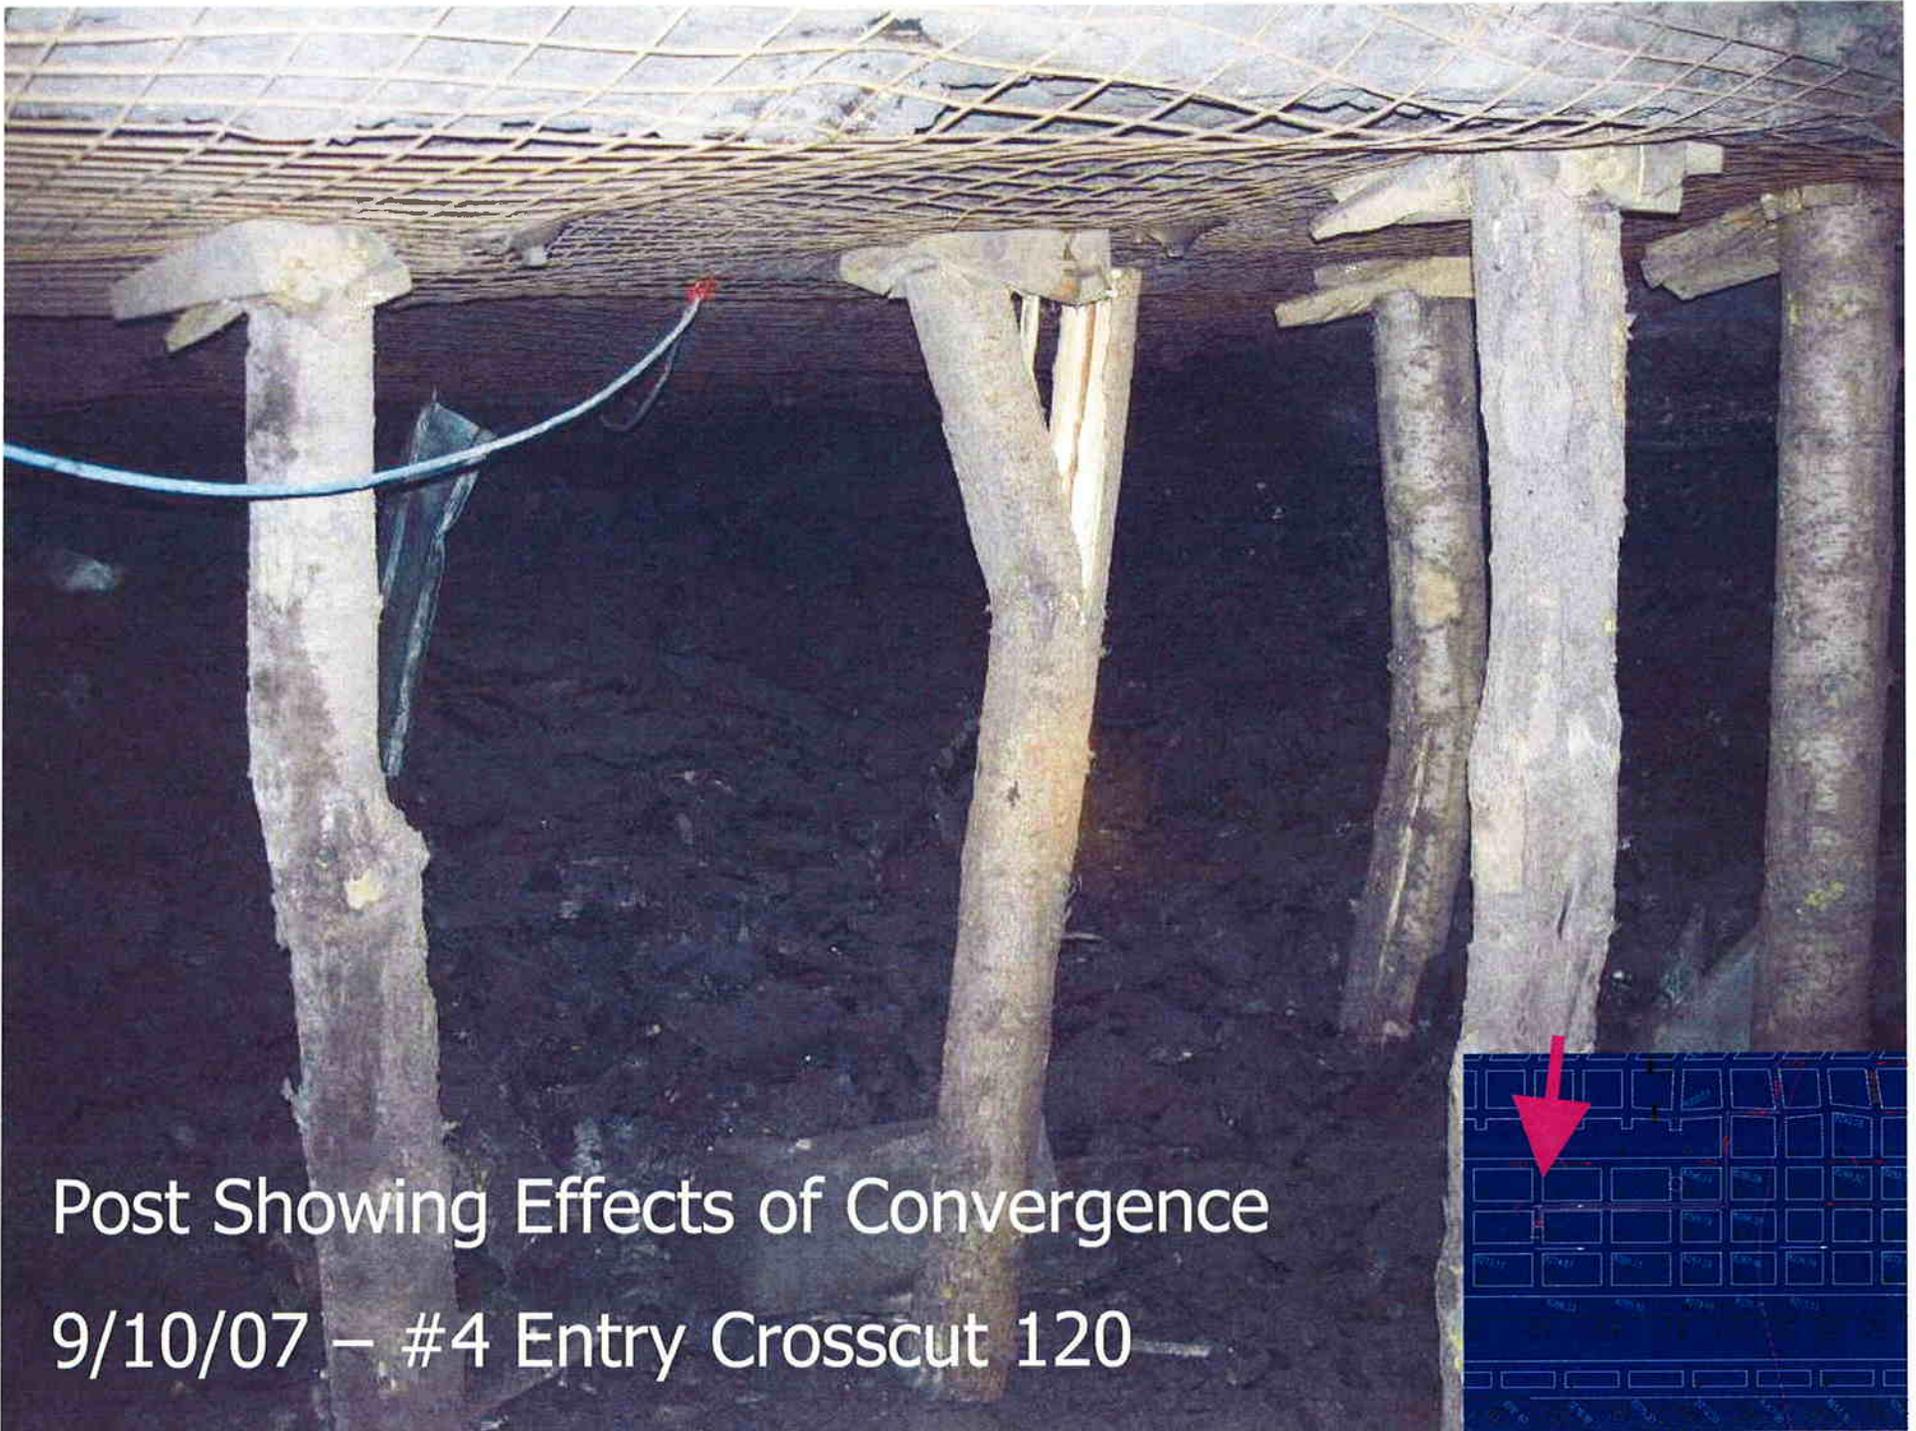
9/10/07 – #4 Entry Crosscut 120

Post Showing Effects of Convergence

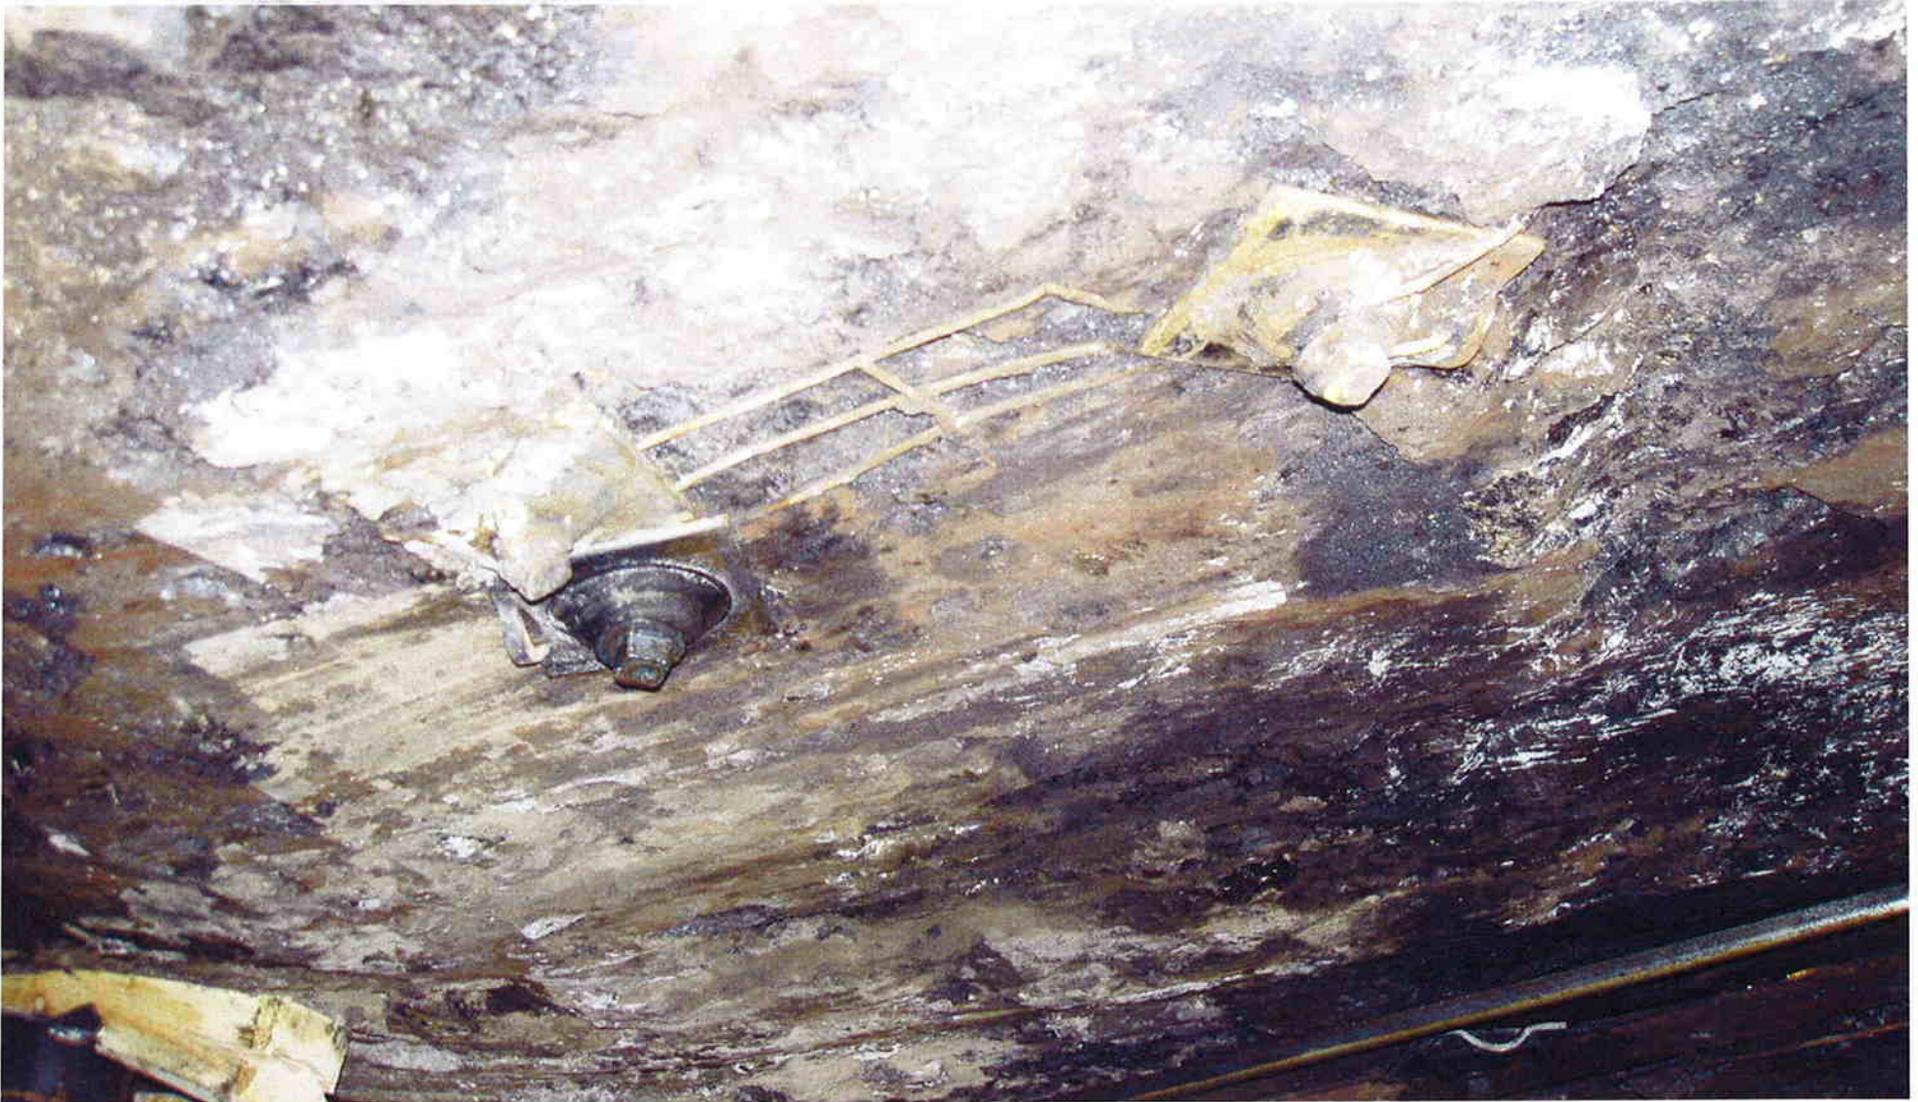
8/14/07 – #1 Entry Near Crosscut 125

# Torn Mesh, and Deformed Roof Bolts from Movement of Barrier During Accident

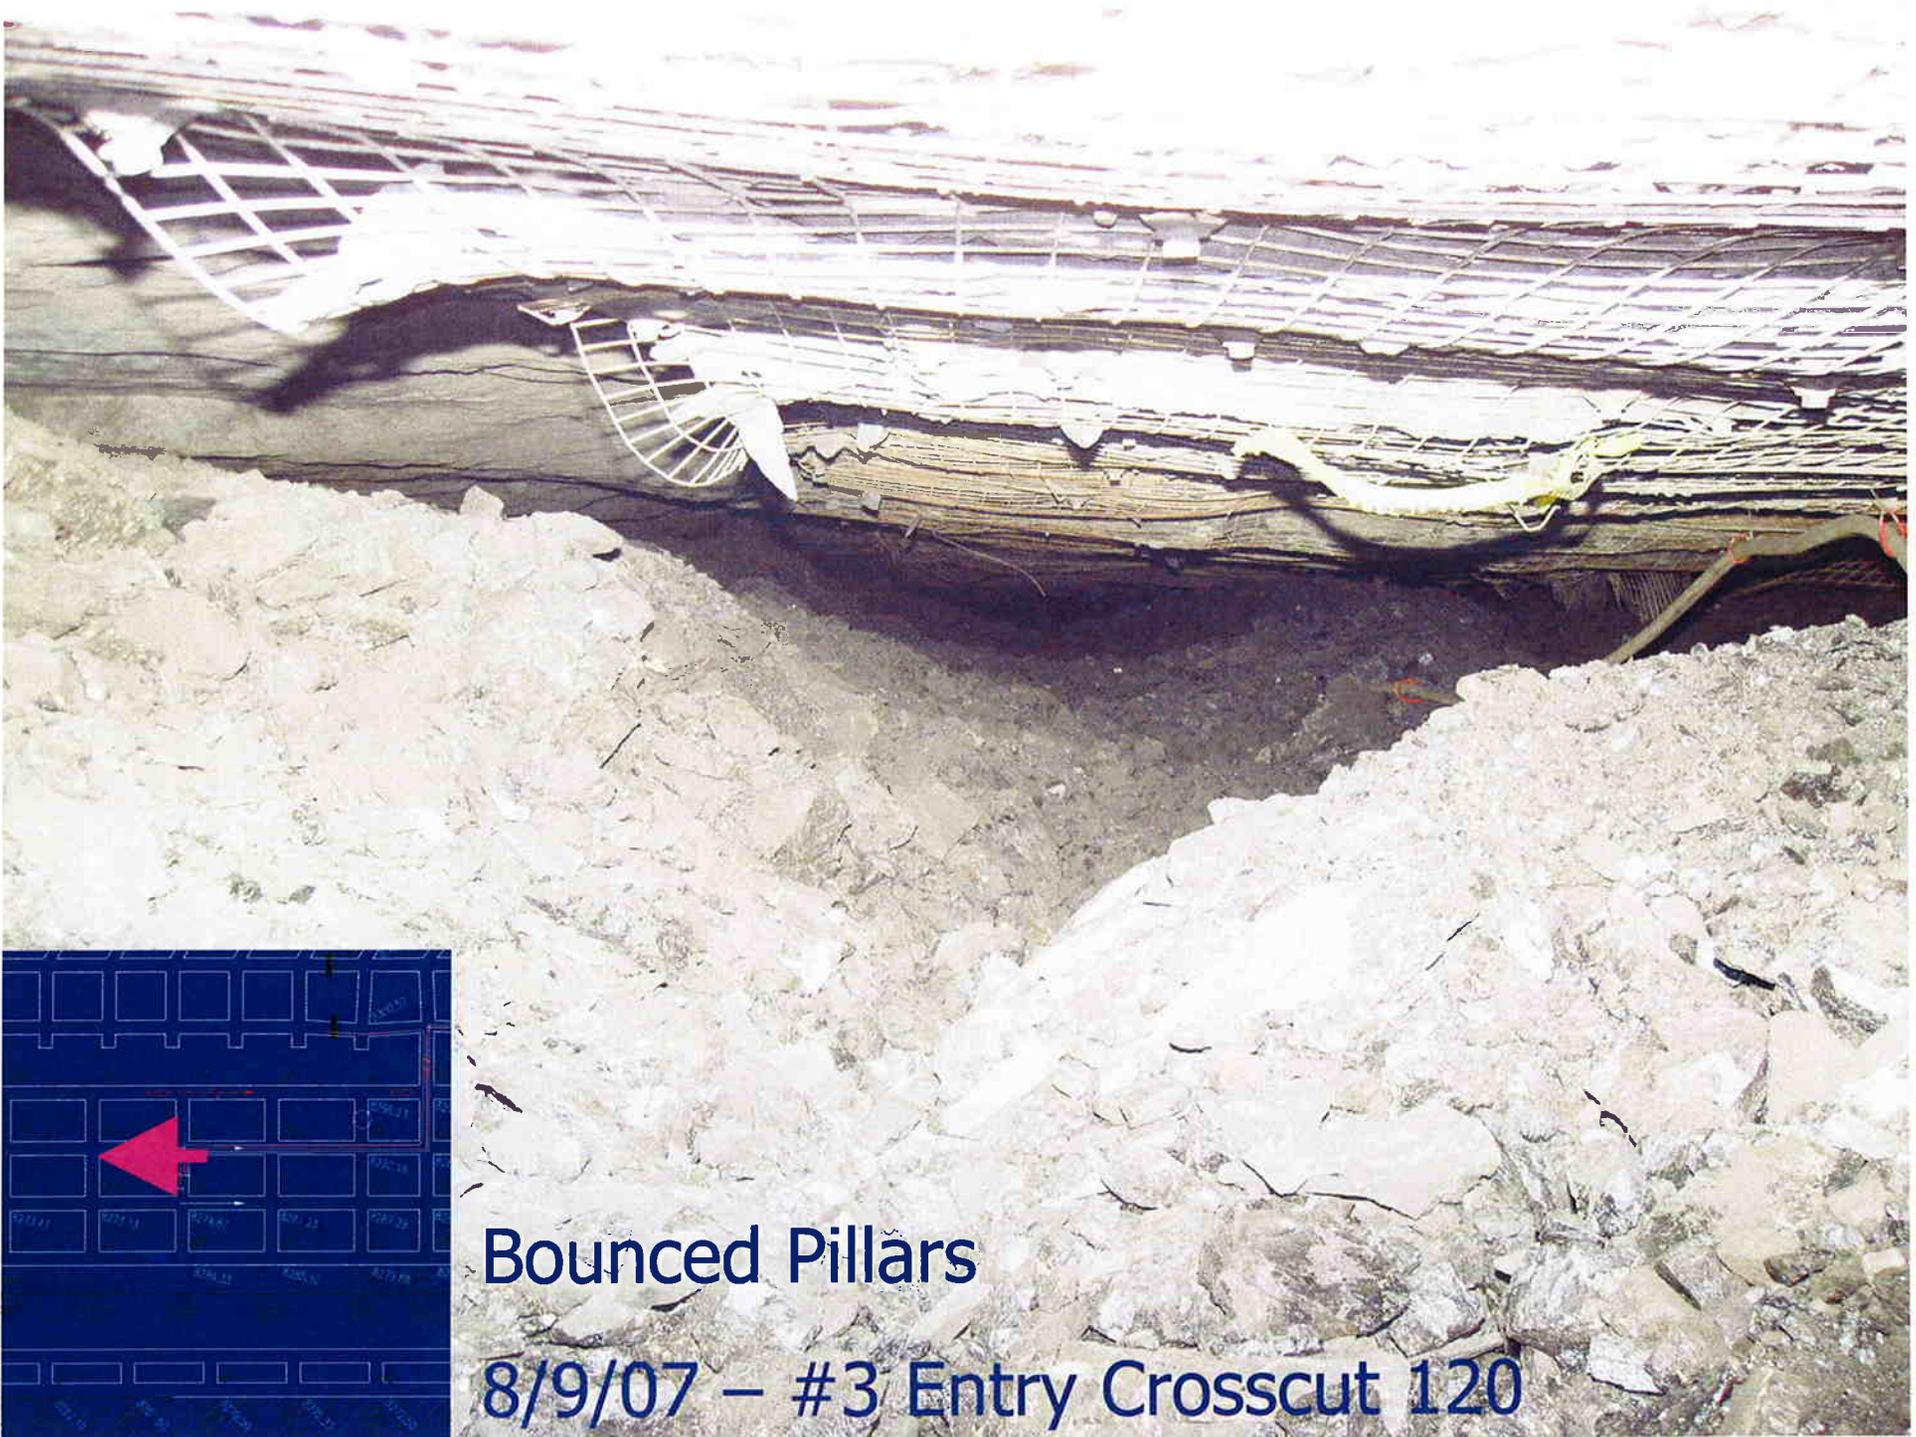
**8/9/07 – #3 Entry Crosscut 120**

**Bounced Pillars**

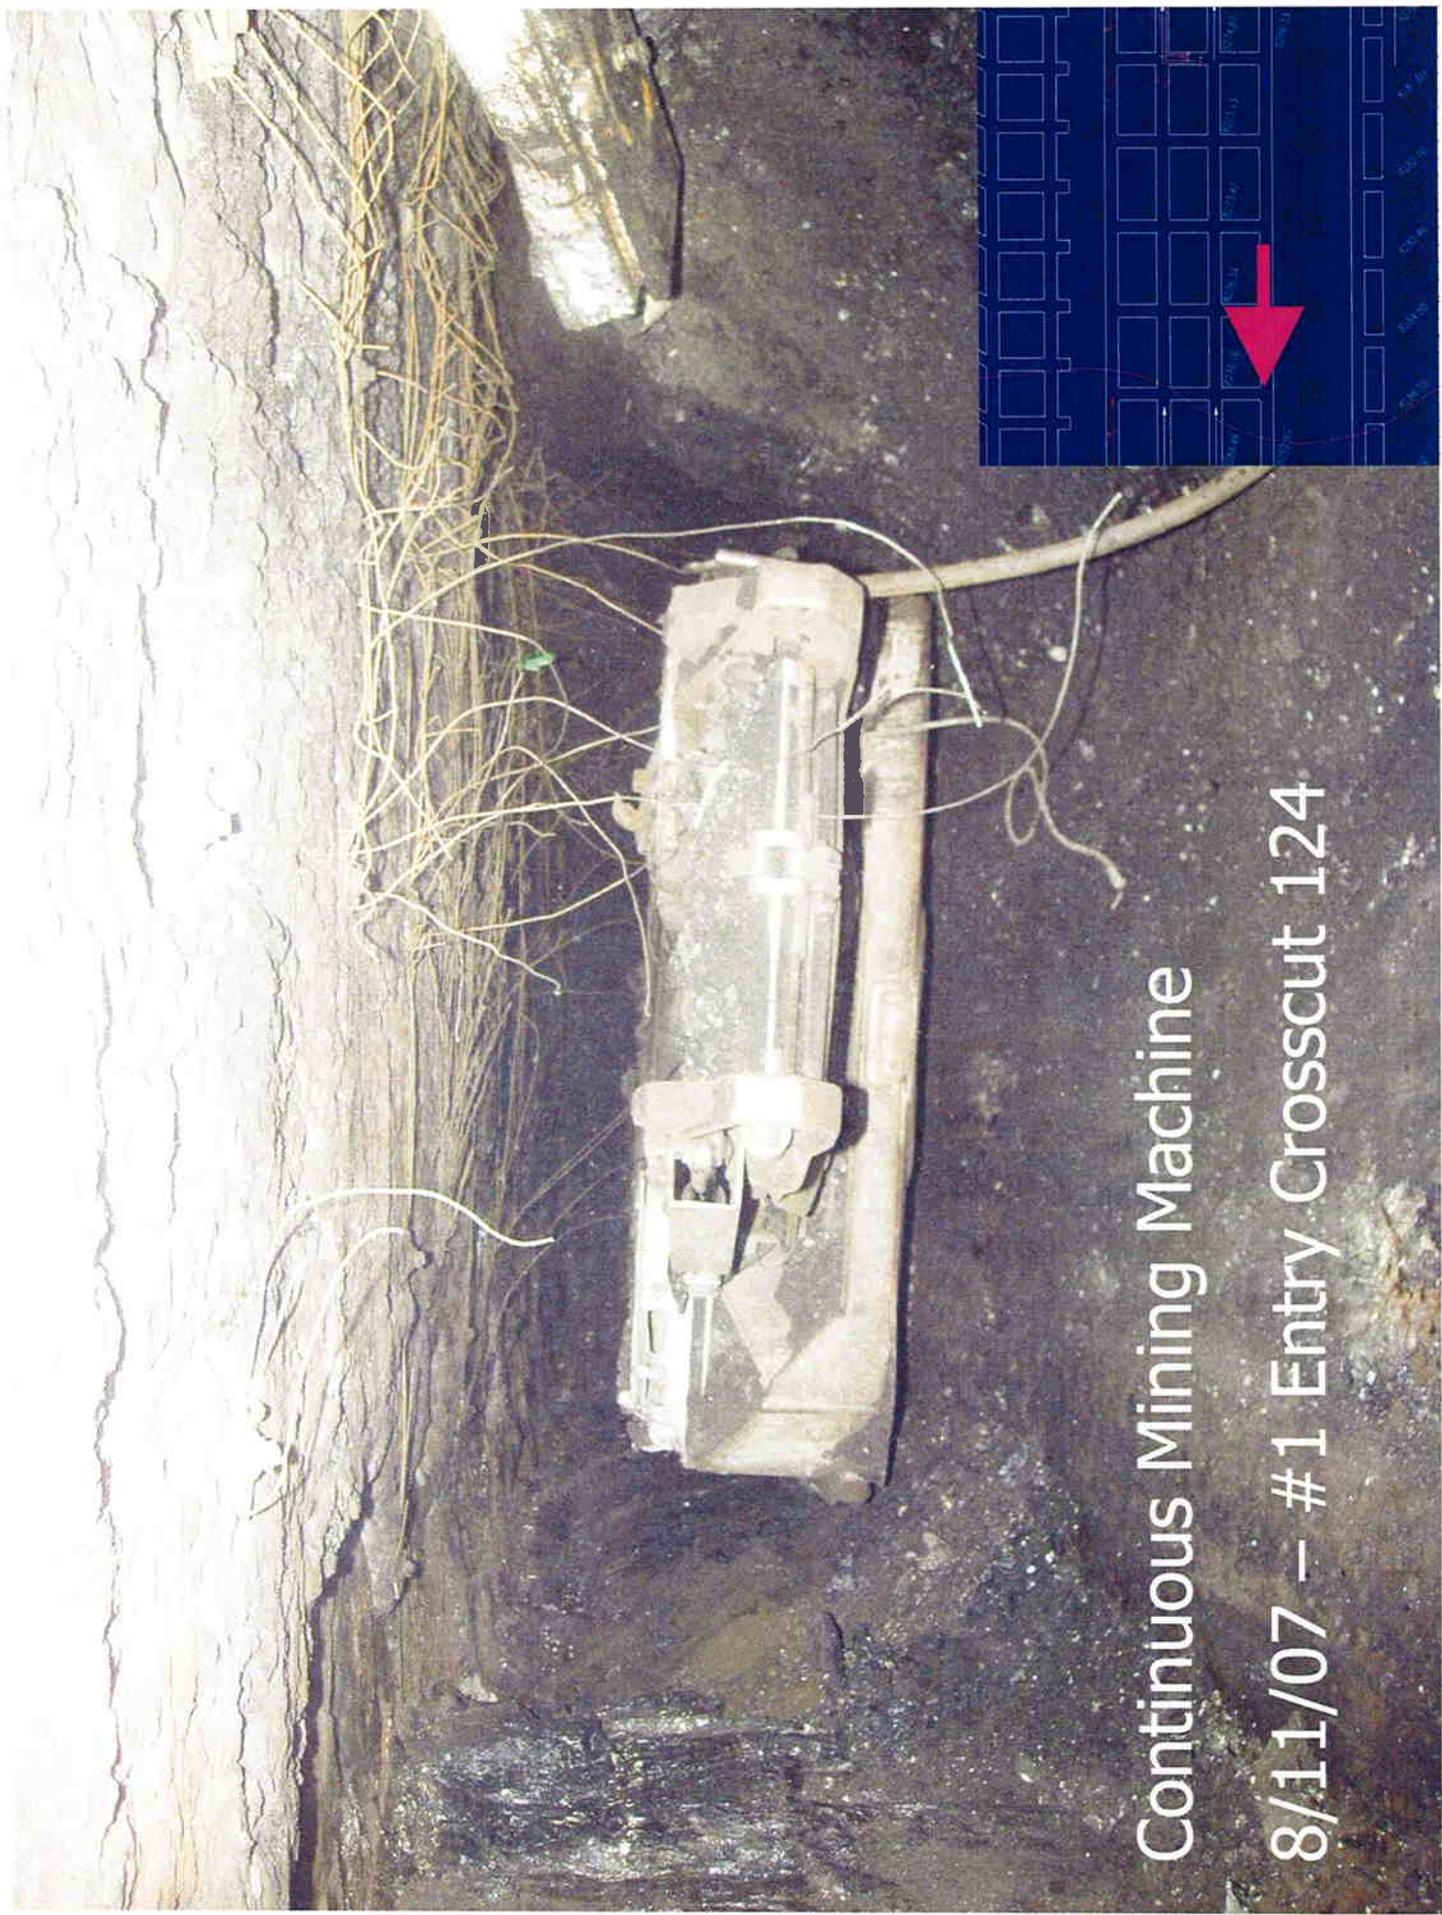
8/11/07 -- #1 Entry Crosscut 124

Continuous Mining Machine

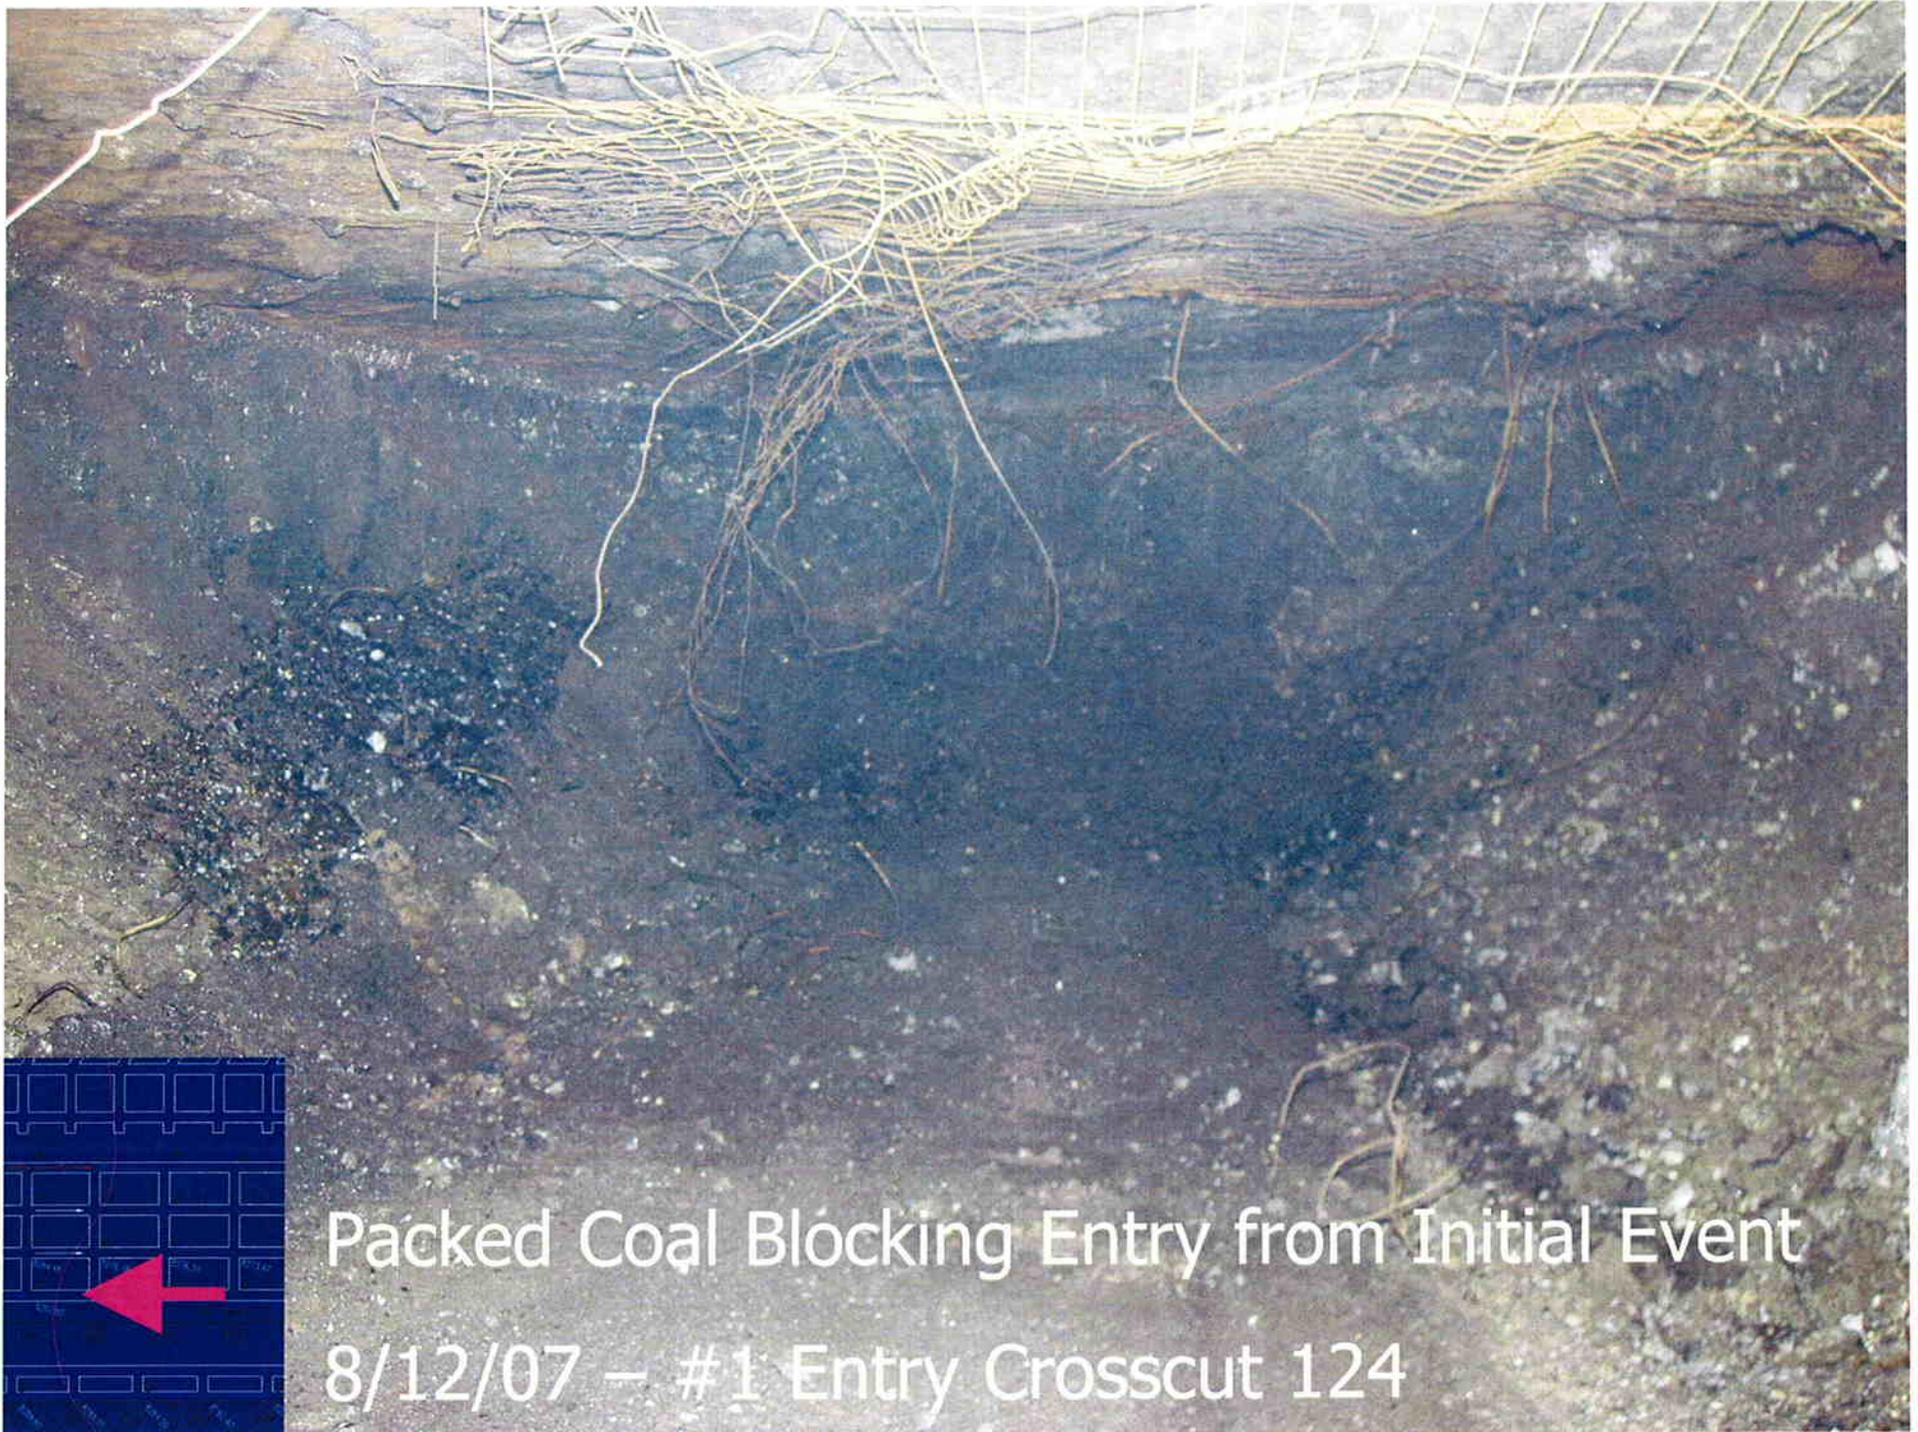
Packed Coal Blocking Entry from Initial Event  
8/12/07 – #1 Entry Crosscut 124

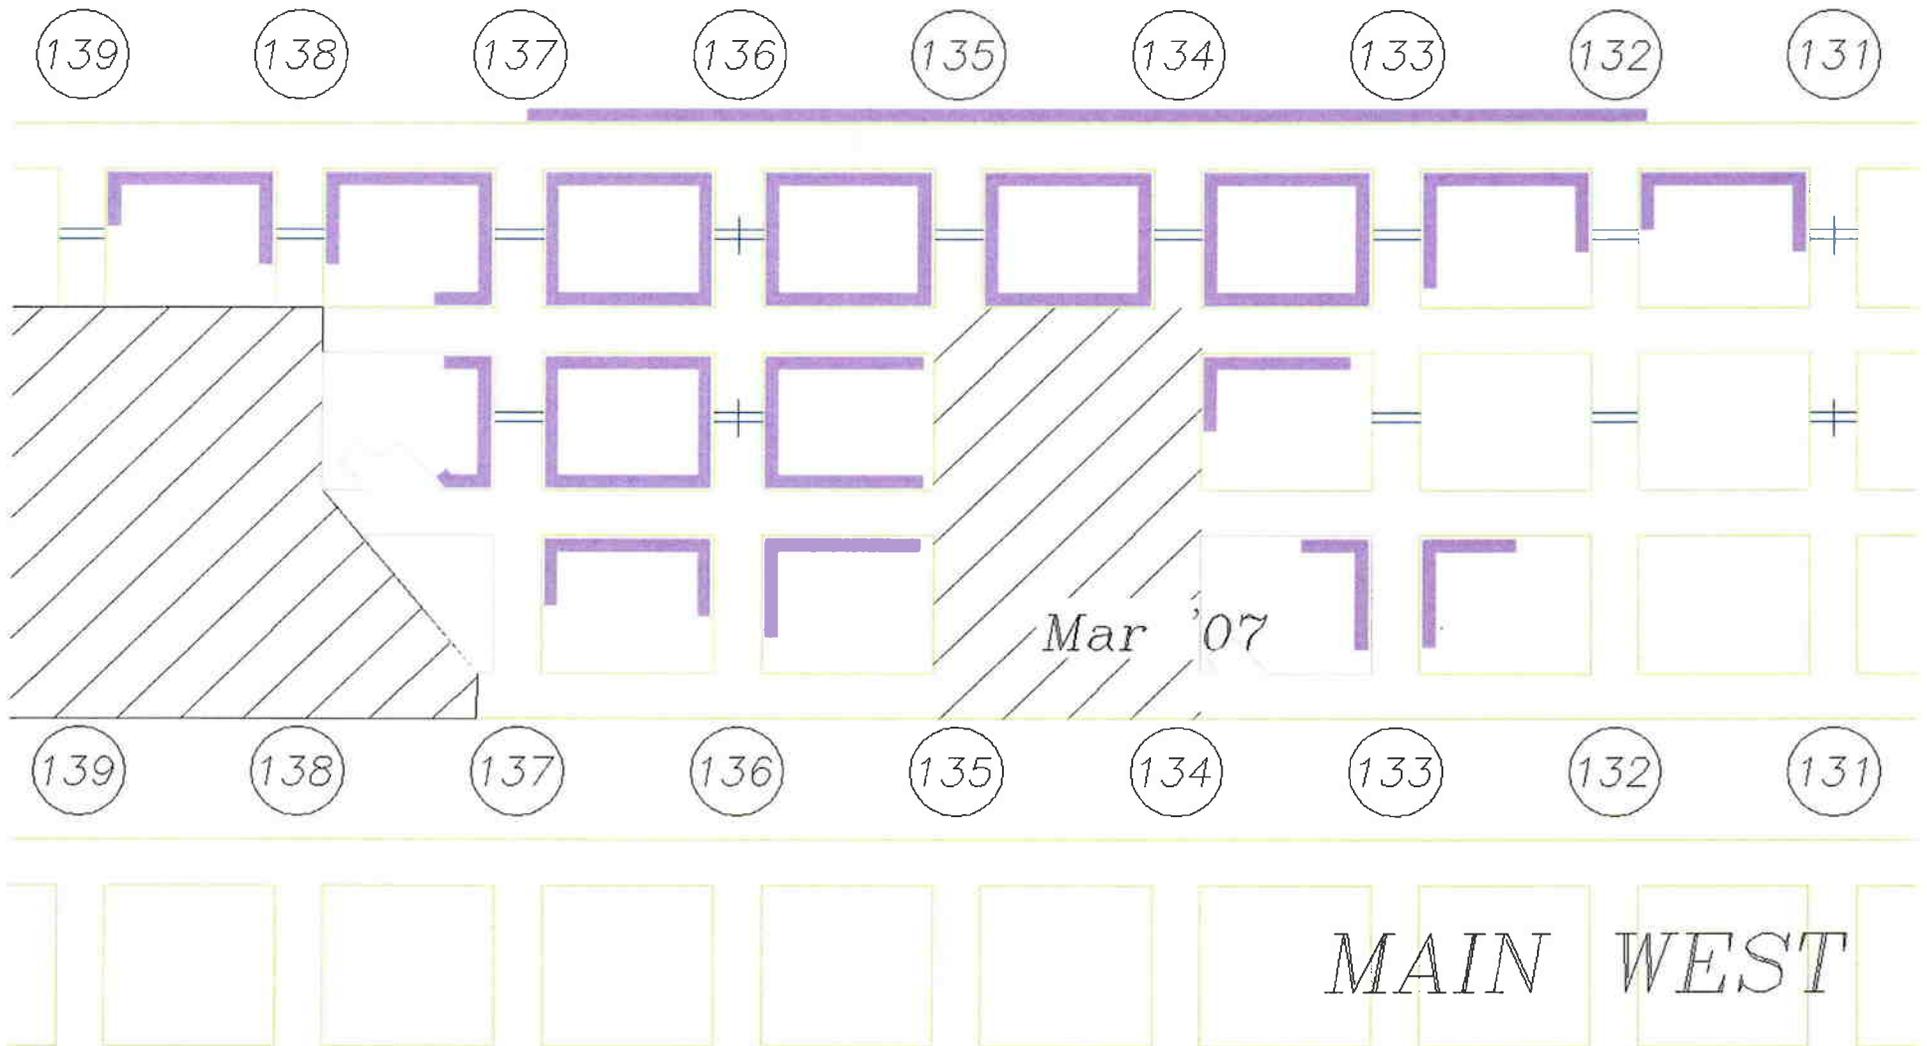
**Area in Main West - North Barrier**  
 Photographed on March 16, 2007 by Mine Operator

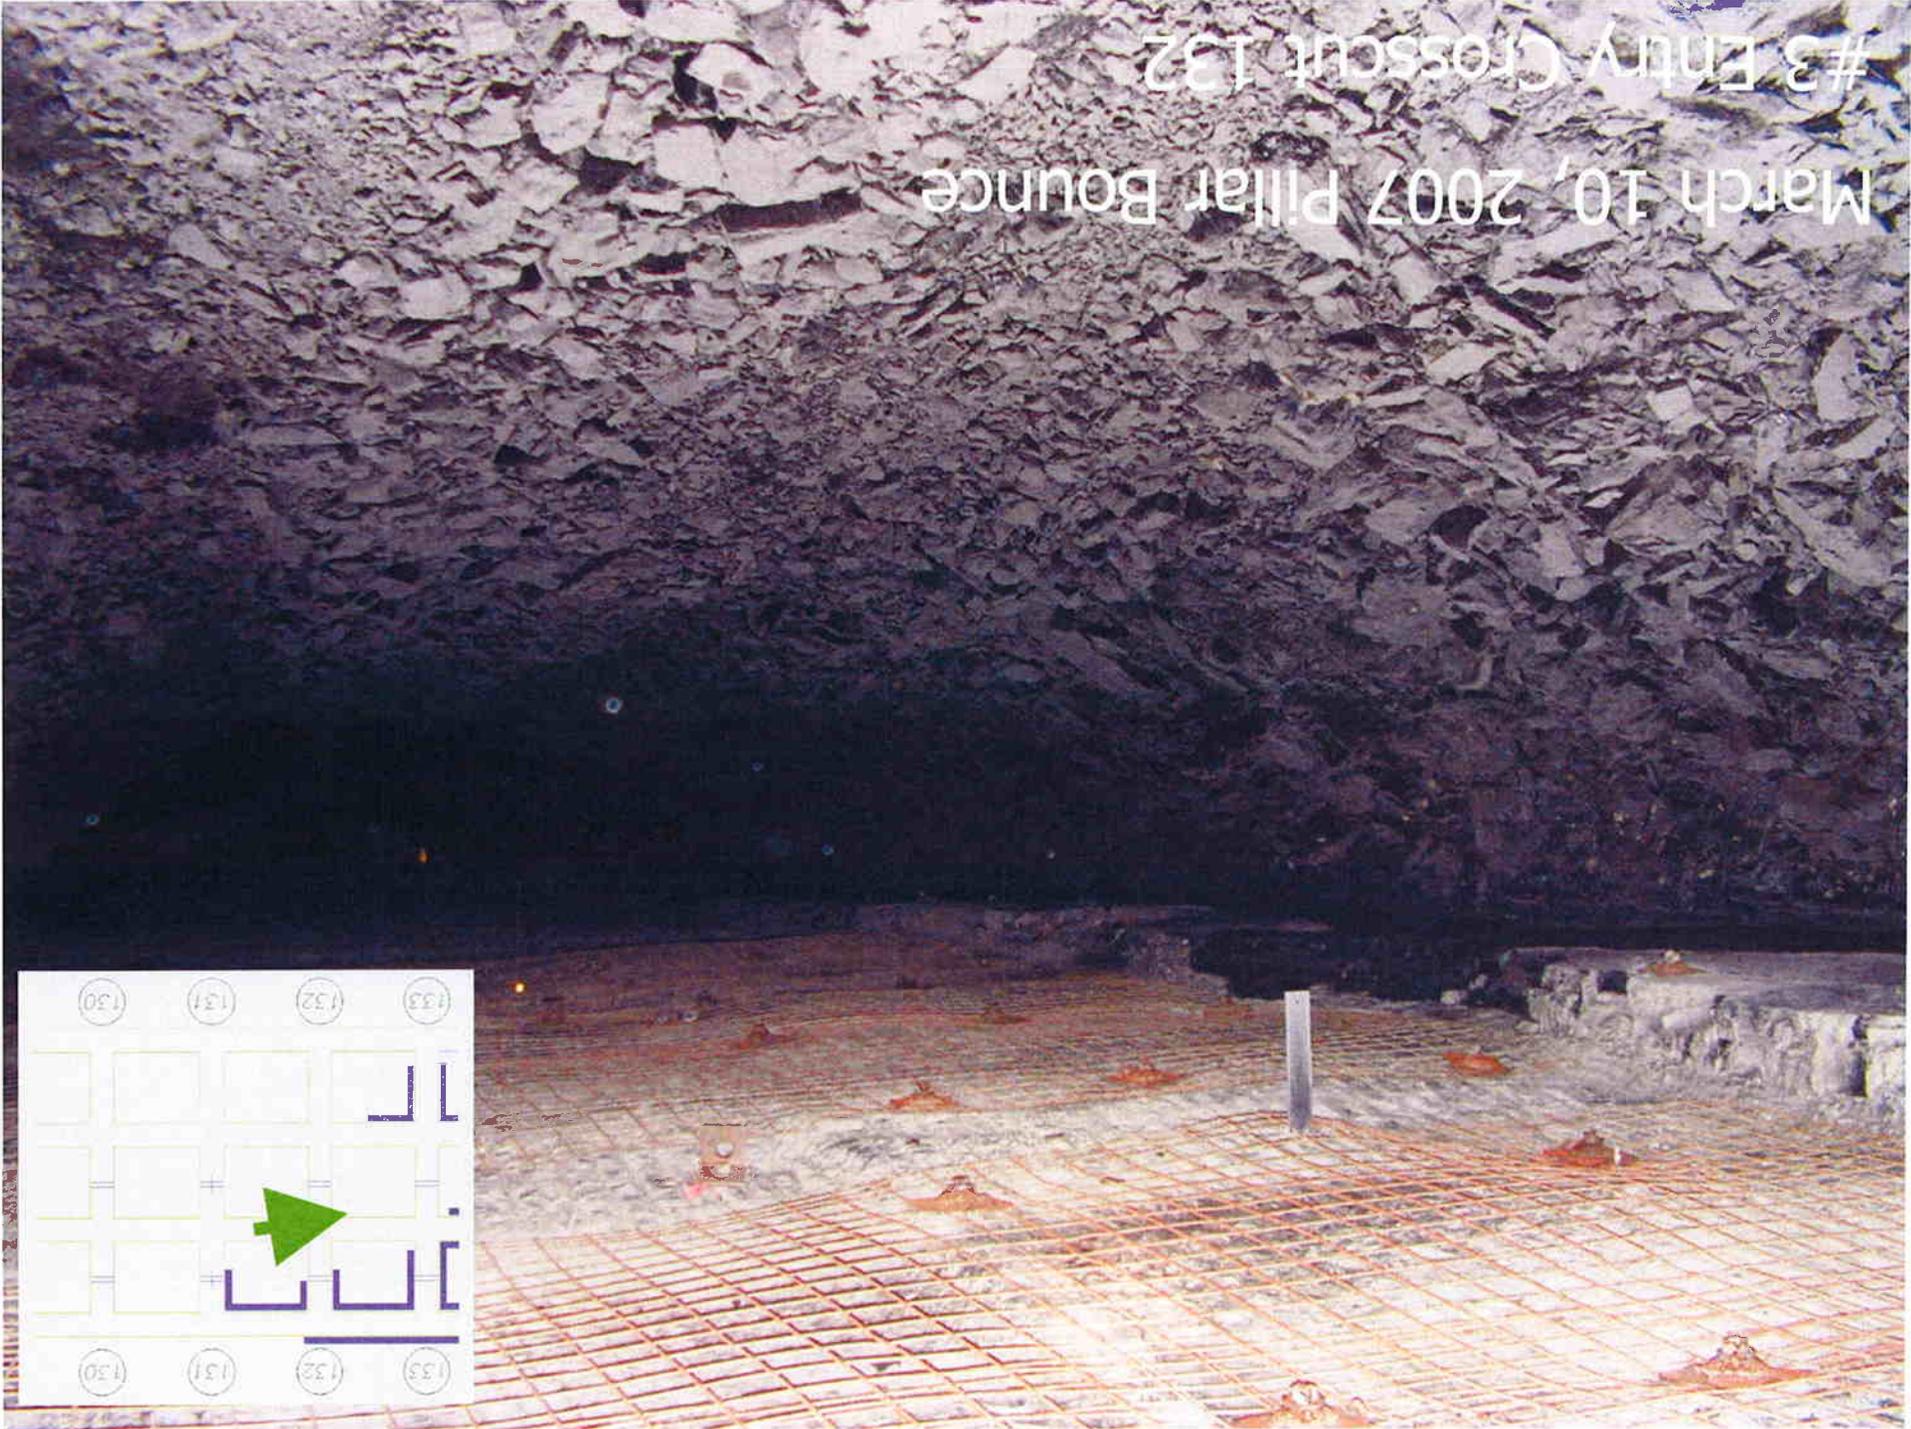
March 10, 2007 Pillar Bounce  
#3 Entry Crosscut 132
